# TOP HAMMER TOOLS **FAILURE ANALYSIS GUIDE**

# FAILURE ANALYSIS GUIDE

# ROCK DRILLING TOOLS FAILURE ANALYSIS GUIDE

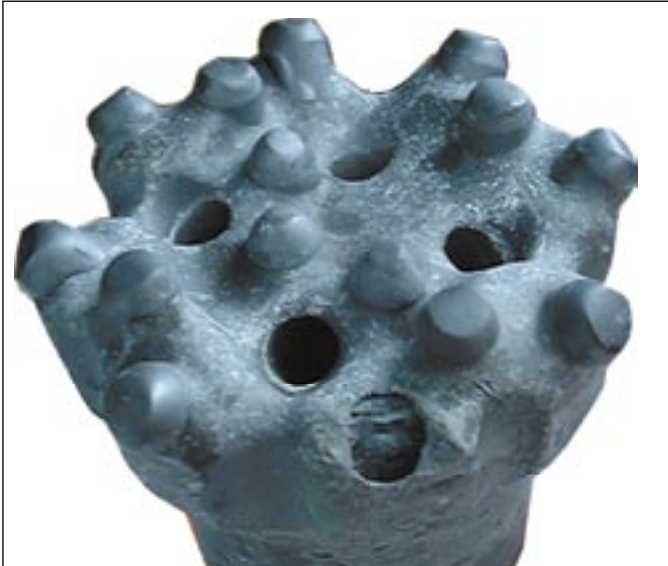
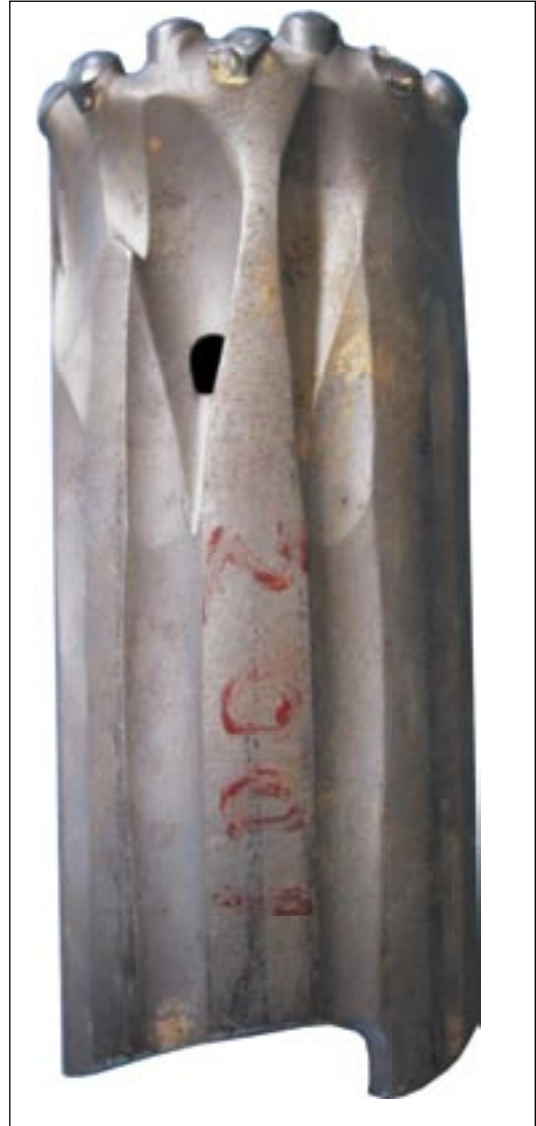
### A:1 BODY WASH

| Failure mode | Probable cause | Recommended action |
|---|---|---|
| <b>A:1 BODY WASH</b><br> | <p>Excessive flushing volume</p> <p>Drilling with excessive flushing volume can in some rock cause sand-blasting of the steel and too big protrusion and breakage of the buttons</p> | <p>Reduce flushing volume</p> <p>Shorten grinding intervals</p> <p>Photograph »</p> |

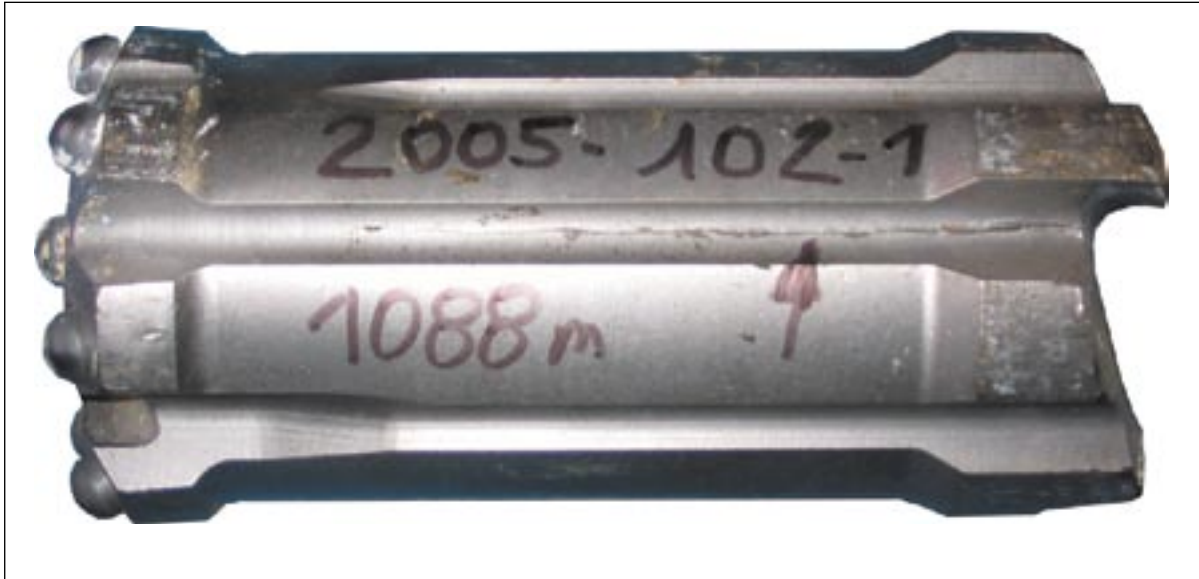
### A:2 SPLIT SKIRT

| Failure mode | Probable cause | Recommended action |
|---|---|---|
| <b>A:2 SPLIT SKIRT</b><br> <p>Error code B2</p> | <p>Drilling with the thread open</p> <p>Wrong procedure when loosening the bit</p> <p>Drilling with too worn threads</p> | <p>Increase feed force. Tighten joints before percussion.</p> <p>Loosen bit with impact mechanism while seated firmly on face or at bottom of hole. Use little feed and no rotation, or use special wrench.</p> <p>Change to new rods. Make sure specified rods are used.</p> <p>Photograph »</p> |

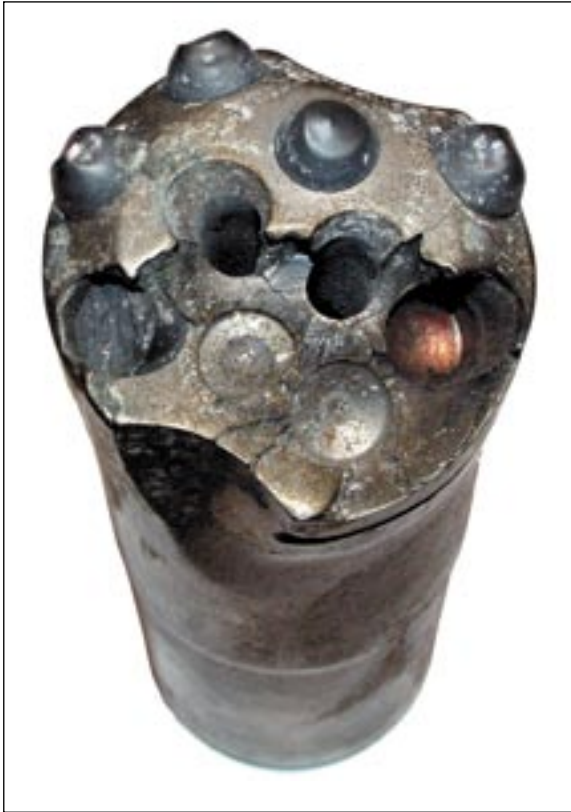
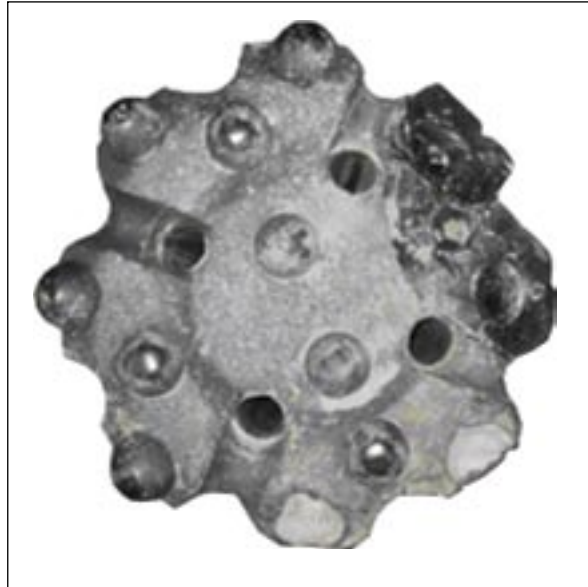
### A:3 STEEL CRACK BETWEEN BUTTON- OR FLUSHING HOLES

| Failure mode | Probable cause | Recommended action |
|---|---|---|
| <b>A:3 STEEL CRACK BETWEEN BUTTON-OR FLUSHING HOLES</b><br> <p>Error code F1f</p> | <p>Final failure when drilling a bit with big buttons (Heavy Duty) in non wearing rock like limestone</p> <p>Manufacturing error. Inferior button hole-drilling precision</p> | <p>Change to bit with other design.</p> <p>Return for analysis.</p> <p>Photograph »</p> |

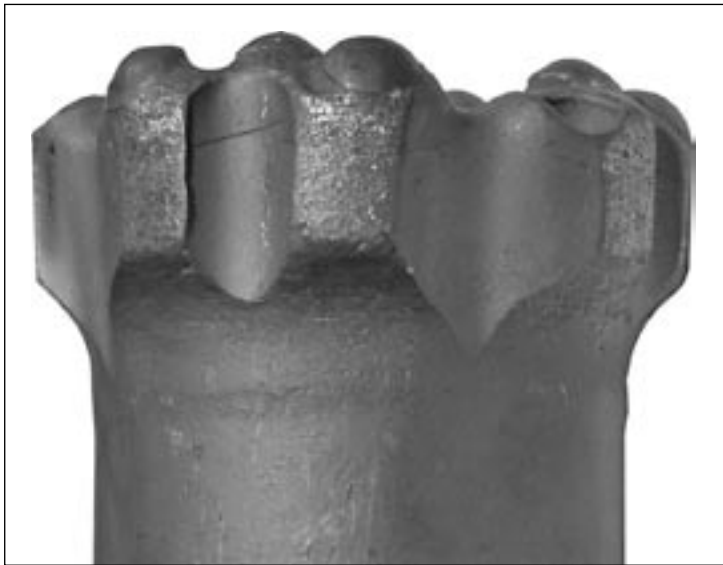
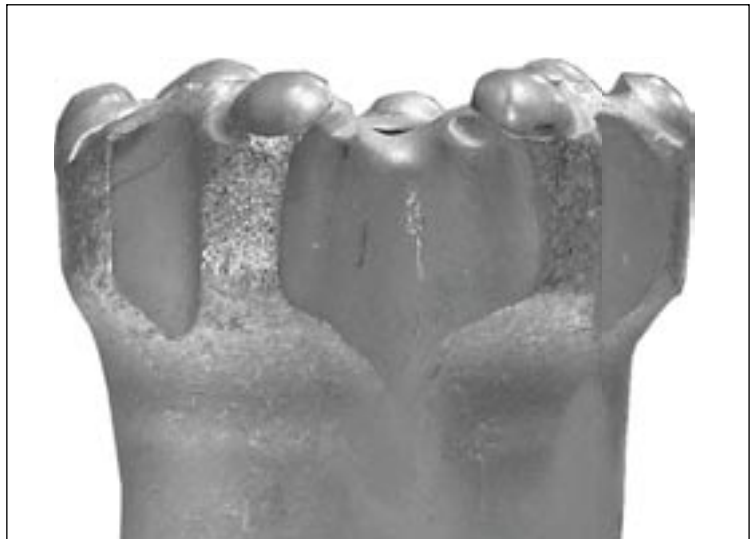
### A:4 STEEL CRACK IN THE BIT BODY ORIGINATING FROM THE BOTTOM OF A BUTTON HOLE

| Failure mode | Probable cause | Recommended action |
|---|---|---|
| <b>A:4 STEEL CRACK STARTING FROM A BUTTON HOLE BOTTOM</b><br><br><i>Error code F1b</i> | <p>Steel fatigue</p> <p>Manufacturing error. Inferior button hole-drilling precision</p> | <p>Normal final failure with long service life</p> <p>The bit is worn out.</p> <p>Return for analysis.</p> <p>Photograph »</p> |

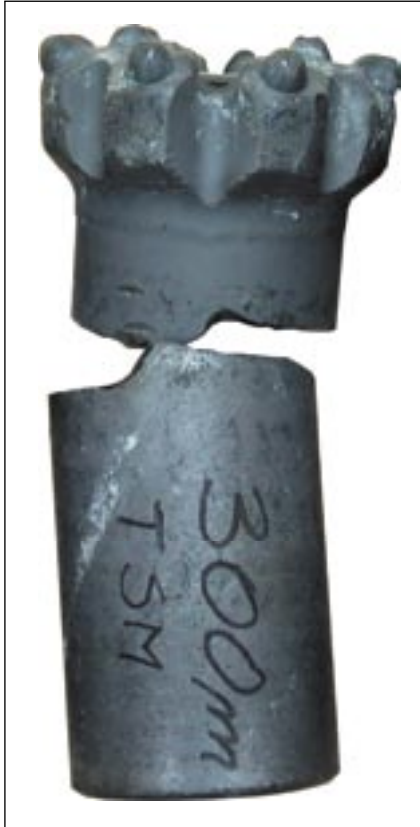
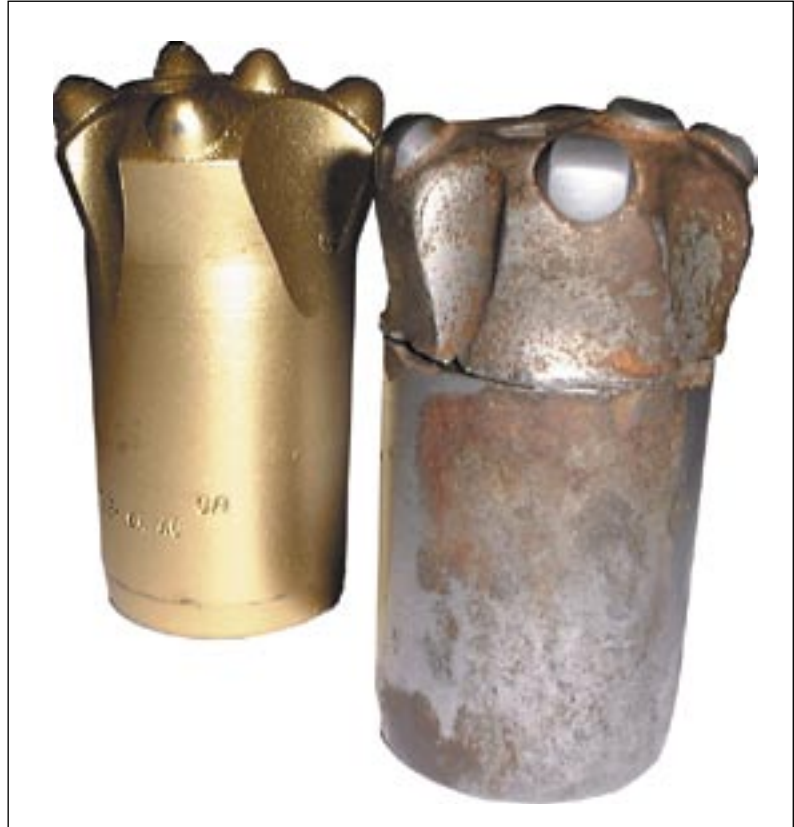
### A:5 SKIRT RING-OFF

| Failure mode | Probable cause | Recommended action |
|---|---|---|
| <b>A:5 SKIRT RING-OFF</b><br><br><i>Error code B1</i> | <p>Excessive rotational speed applied to stuck bit</p> <p>Bad collaring practices</p> <p>Corrosion</p> <p>Hammering on bit to break connection</p> <p>Excessive back hammering</p> <p>Too low rock resistance</p> <p>Fatigue</p> | <p>Apply minimal amount of hammer pressure to free bit before increasing rotation speed.</p> <p>Reduce percussion and feed when collaring.</p> <p>Improve storage practices. Neutralise flushing agent.</p> <p>Loosen bit with impact mechanism while seated firmly against the rock. Use little feed and no rotation, or use special wrench.</p> <p>Use retrac bit.</p> <p>Reduce impact power.</p> <p>Normal failure with long life</p> <p>Photograph »</p> |

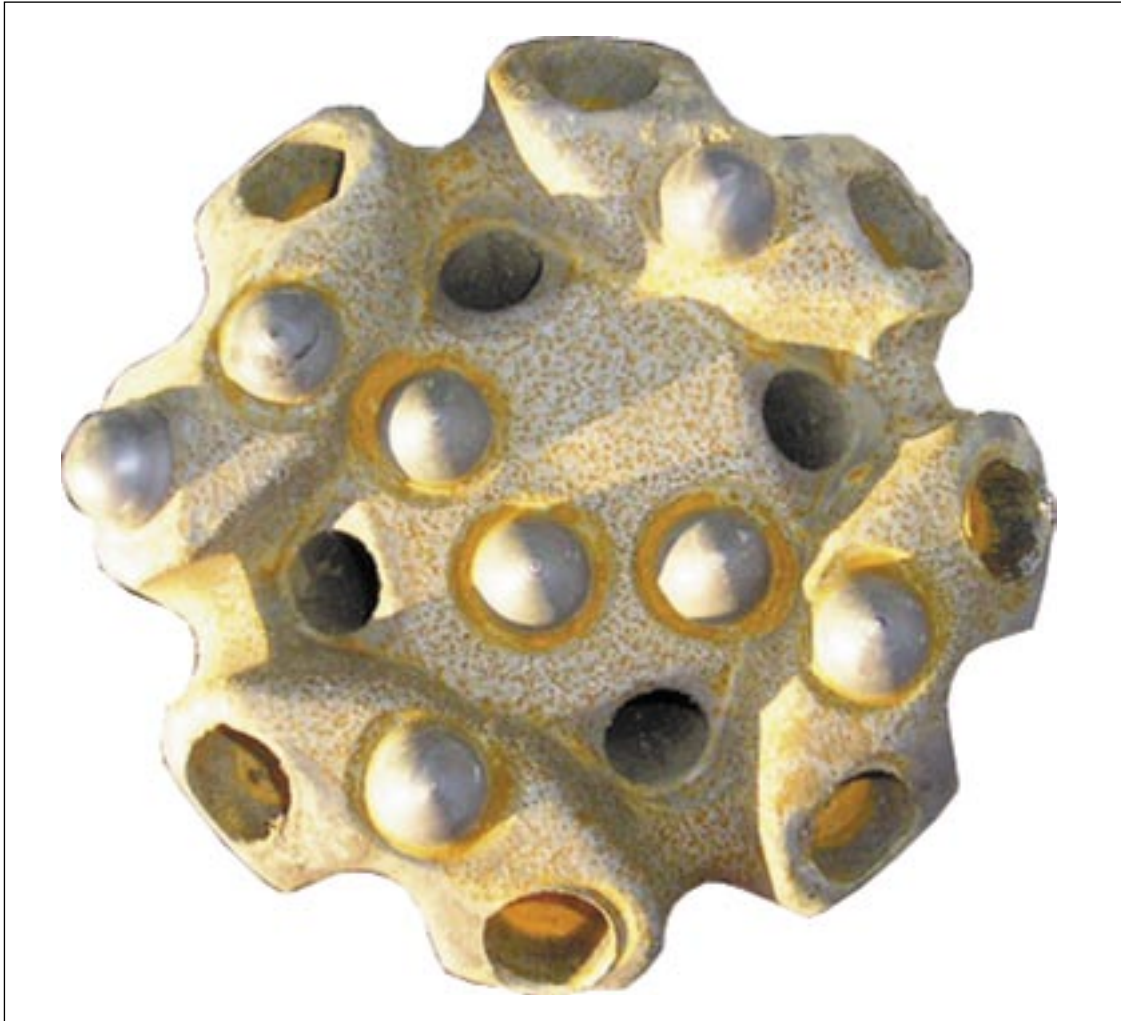
## A:6 LOST BUTTONS

| Failure mode | Probable cause | Recommended action |
|---|---|---|
| <b>A:6 LOST BUTTONS</b><br> | <p>Free hammering</p> <p>Inadequate feed pressure</p> <p>Scaling with bit</p> <p>Incorrect size correlation between button and button hole</p> | <p>Do not engage full percussions unless the bit is firmly seated againsts rock. Use reduced percussion when collaring on uneven surfaces.</p> <p>Increase feed pressure.</p> <p>Use proper scaling tool.</p> <p>Return for analysis.</p> <p>Photograph »</p> |

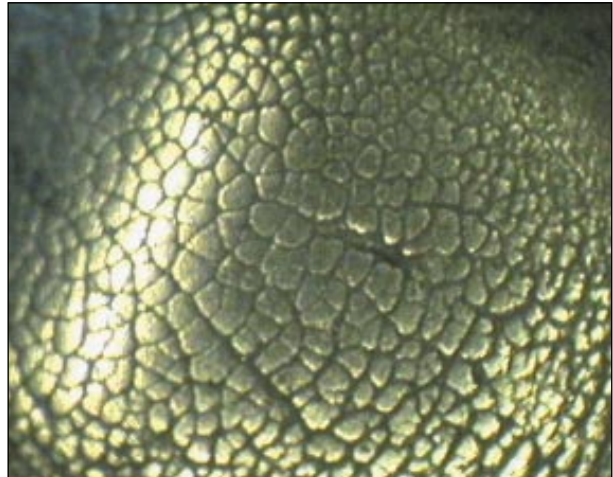
### A:7 SNAKESKIN OR MICRO-CRACKS IN CEMENTED CARBIDE

| Failure mode | Probable cause | Recommended action |
|---|---|---|
| <b>A:7 SNAKESKIN OR MICRO-CRACKS IN CEMENTED CARBIDE</b><br><br>Error code S9 | <p>Drilling in non-abrasive rock creates micro-fractures in the carbide sometimes looking like snake skin.</p> <p>The rock leaves a shiny surface on the buttons and a fatigue in the surface of the cemented carbide, leading to button failure.</p> | <p>Earlier regrinding even if there are no or small wear flats</p> <p>Use a softer carbide grade.</p> <p><i>Photograph »</i></p> |

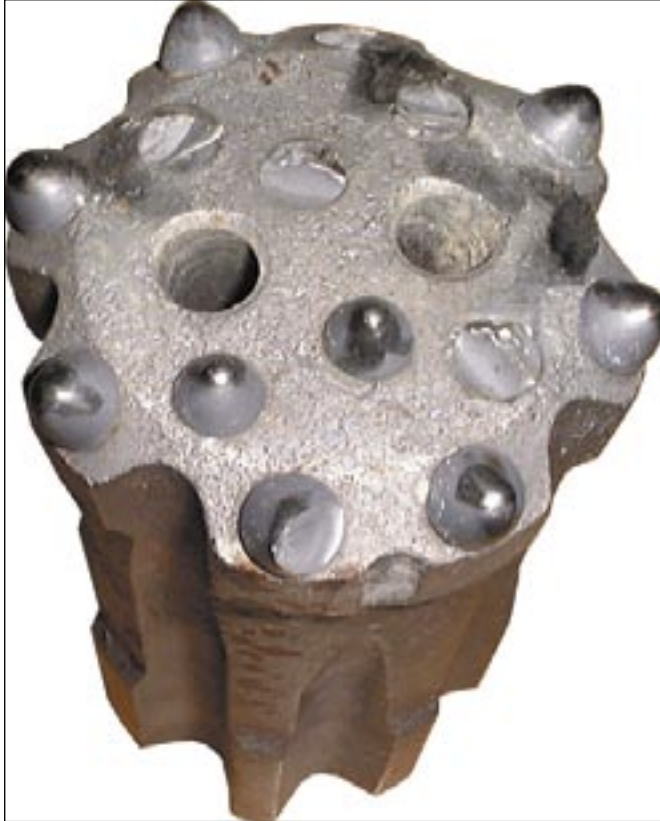
## A:10 BUTTON CHIPPED

| Failure mode | Probable cause | Recommended action |
|---|---|---|
| <b>A:10 BUTTON CHIPPED</b><br><br><i>Error code S3</i> | <p>Overdrilling</p> <p>Snakeskin. Overdrilling in soft, non-abrasive rock leaves a shiny surface on the buttons.</p> <p>Button carbide is too hard.</p> <p>Button not in contact with virgin material on impact</p> | <p>Shorten grinding intervals. Regrind when the wear flats are max. 1/3 of the button diameter.</p> <p>Regularly inspect the bits and grind to remove micro-cracks from the surface of the carbides.</p> <p>Choose softer or tougher grade of carbide.</p> <p>Increase rotation speed.</p> <p><i>Photograph »</i></p> |

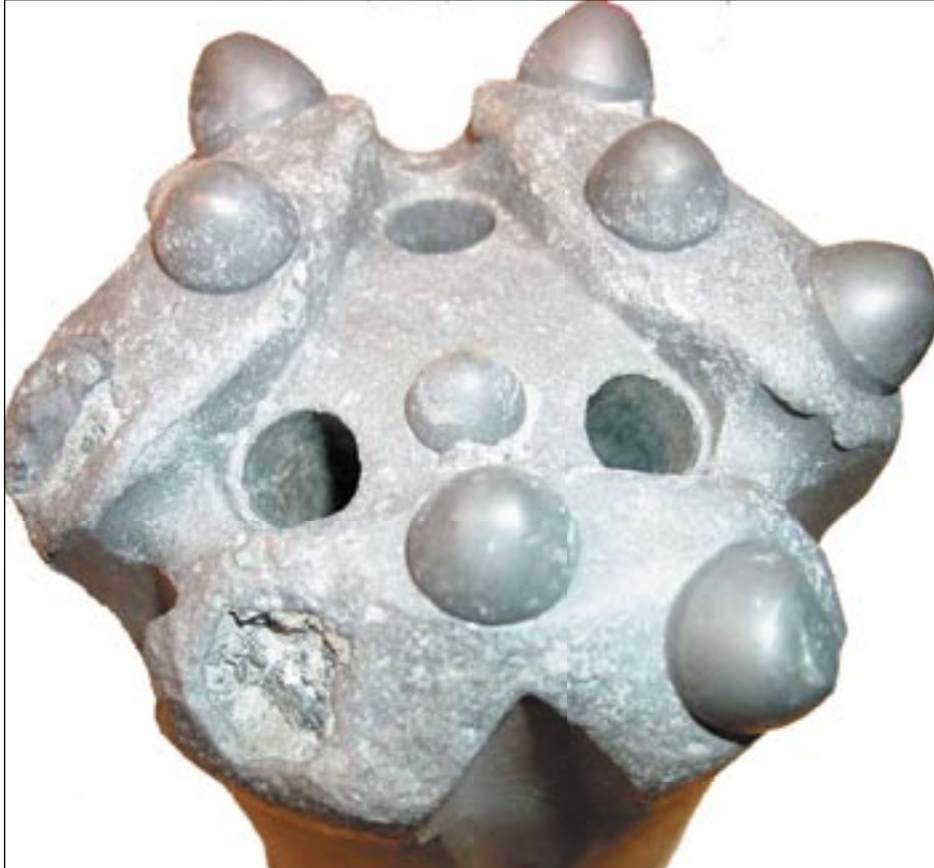
### A:11 BUTTON CRUSHED DOWN TO LEVEL OF BIT BODY

| Failure mode | Probable cause | Recommended action |
|---|---|---|
| <b>A:11 BUTTONS CRUSHED DOWN TO LEVEL OF BIT BODY</b><br><br><i>Error code S4</i> | <p>Snakeskin. Overdrilling in soft, non-abrasive rock leaves a shiny surface on the buttons and a fatigue in the surface of the cemented carbide, looking like snakeskin</p> <p>Overdrilling</p> <p>Incorrect grade of carbide</p> <p>Incorrect grinding procedures</p> | <p>Regularly inspect the bits and regrind regularly although the buttons seem not worn, just polished, to remove micro-cracks from the surface of the carbides.</p> <p>Shorten grinding intervals.</p> <p>Change carbide grade. See product catalogue or bit selection guide.</p> <p>Dry grinding can result in snakeskin fatigue. Employ wet grinding.</p> <p><i>Photograph »</i></p> |

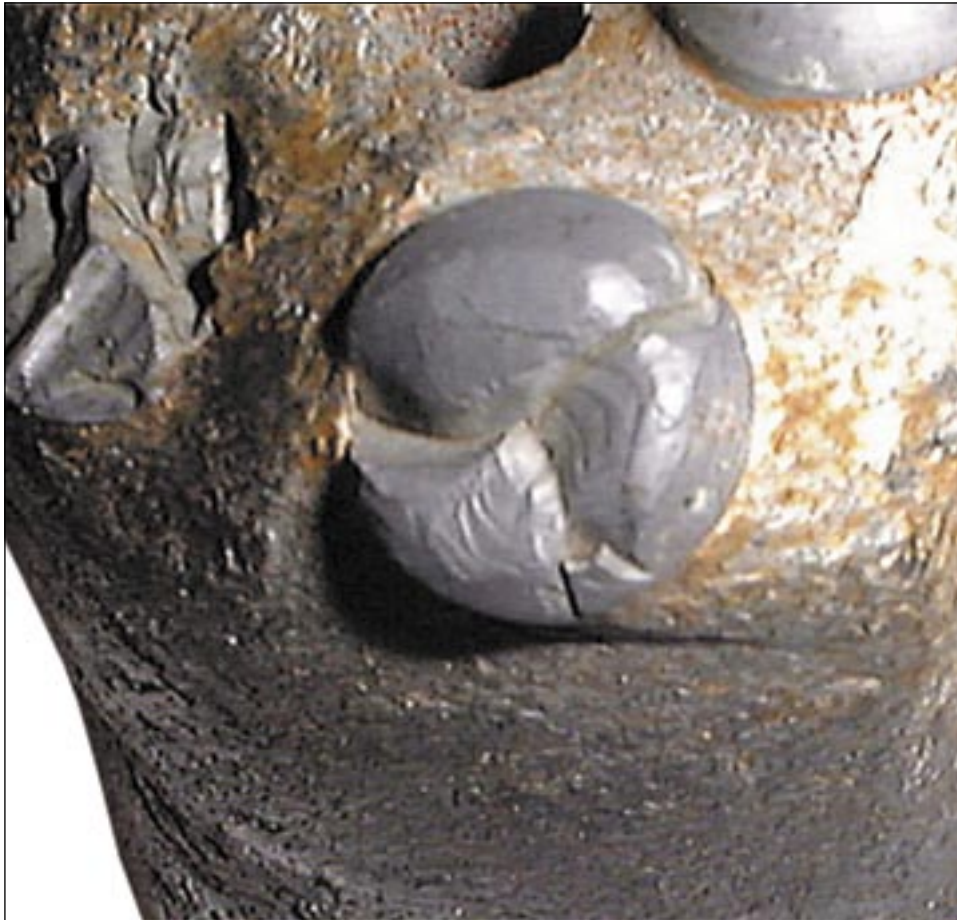
### A:12 BUTTON CRACKED

| Failure mode | Probable cause | Recommended action |
|---|---|---|
| <b>A:12 BUTTON CRACKED</b><br><br><i>Error code S1</i> | <p>Overdrilling</p> <p>Snakeskin</p> <p>Incorrect grinding procedures</p> <p>Button carbide is too hard</p> | <p>Regrind when the wear flats are max 1/3 of the button diameter.</p> <p>Regularly inspect the bits and grind to remove micro-cracks from the surface of the carbide.</p> <p>Dry grinding can give snakeskin fatigue. Employ wet grinding.</p> <p>Choose softer or tougher grade of carbide.</p> <p><i>Photograph »</i></p> |

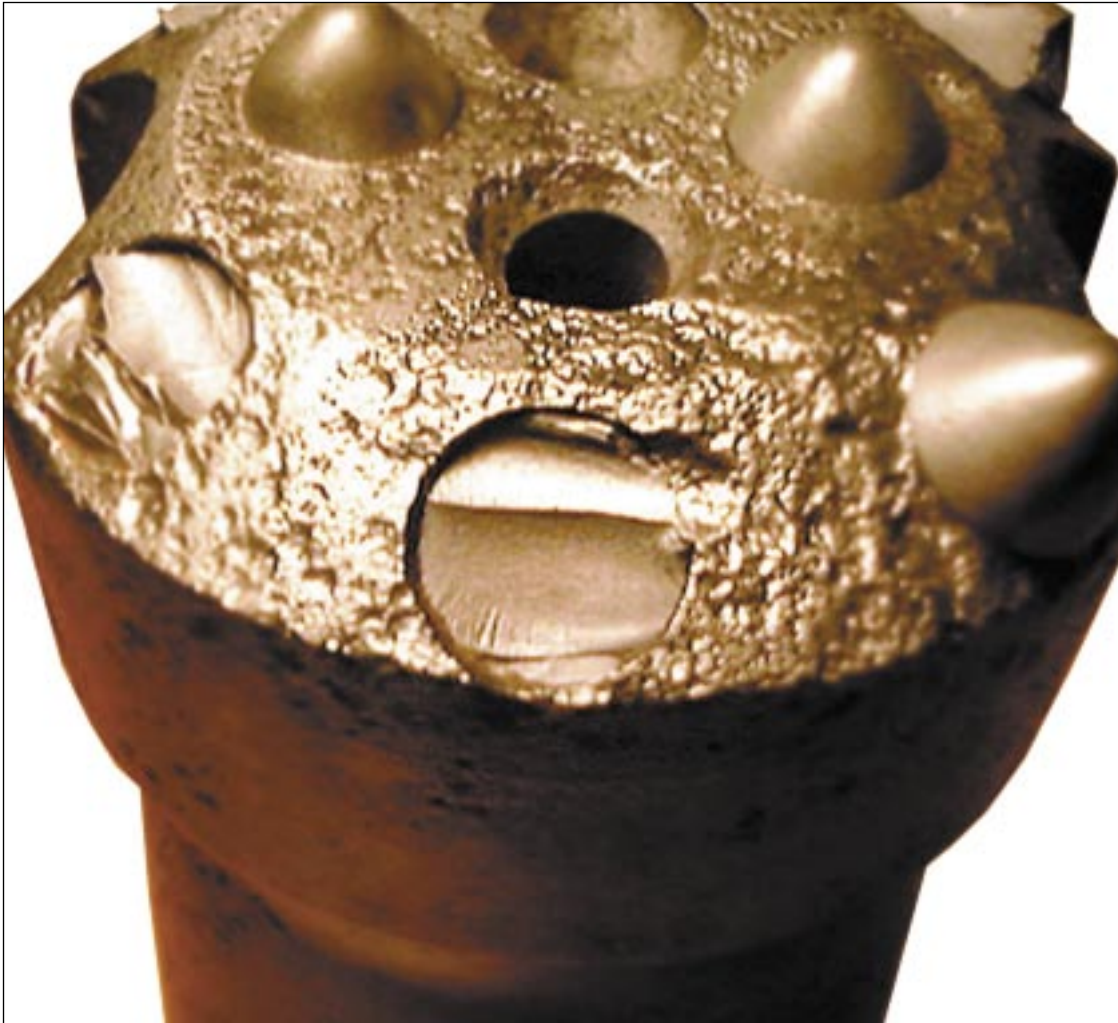
### A:13 TOP OF BUTTON SHEARED OFF LEVEL WITH BODY

| Failure mode | Probable cause | Recommended action |
|---|---|---|
| <b>A:13 TOP OF BUTTON SHEARED OFF LEVEL WITH BODY</b><br><br><i>Error code S7</i> | <p>Overdrilling</p> <p>Drilling into metal</p> <p>Snakeskin</p> <p>Excessive button protrusion through incorrect grinding. Protrusions greater than 3/4 of the button diameter will not provide sufficient support to resist the tensile forces that the buttons may encounter.</p> | <p>Shorten grinding intervals. Regrind when the wear flats are max 1/3 of the button diameter.</p> <p>Ensure correct drilling practices.</p> <p>Regularly inspect the bits and grind to remove micro-cracks from the surface of the cemented carbide.</p> <p>Shorten grinding intervals.</p> <p><i>Photograph »</i></p> |

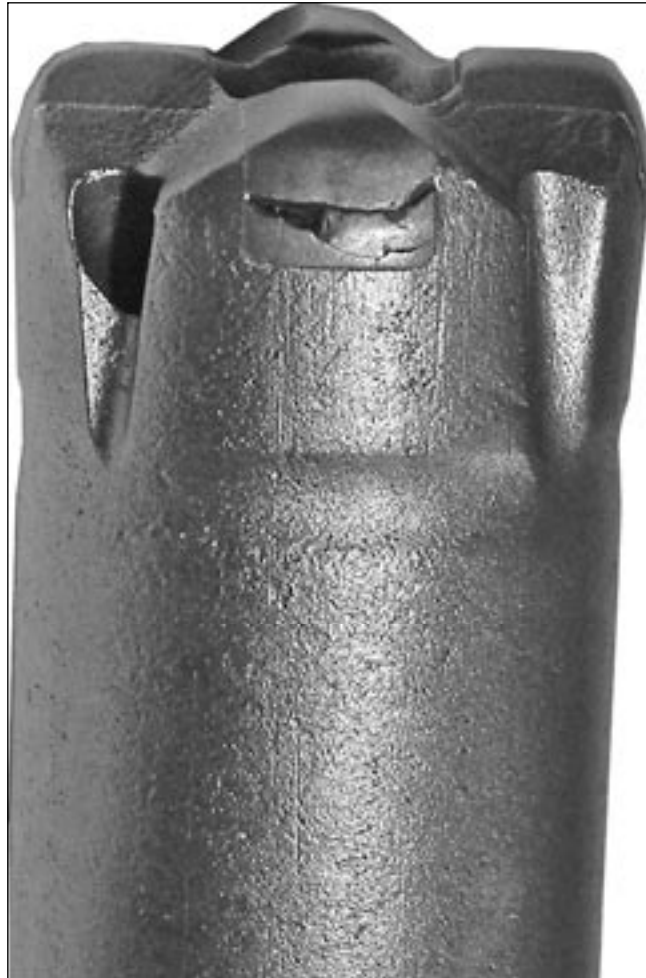
### **B:2 TRANSVERSAL CRACK**

| Failure mode | Probable cause | Recommended action |
|---|---|---|
| <b>B:2 TRANSVERSAL CRACK</b><br><br><i>Error code S1</i> | <p>Overheating from improper grinding</p> <p>Anti-taper from abrasive rock</p> <p>Grinding scratches due to wrong grinding wheel</p> | <p>Regrind bit to its original shape. Follow proper bit grinding procedures.</p> <p>Shorten grinding intervals.</p> <p>Check grinding procedures and grinding wheel.</p> <p><i>Photograph »</i></p> |

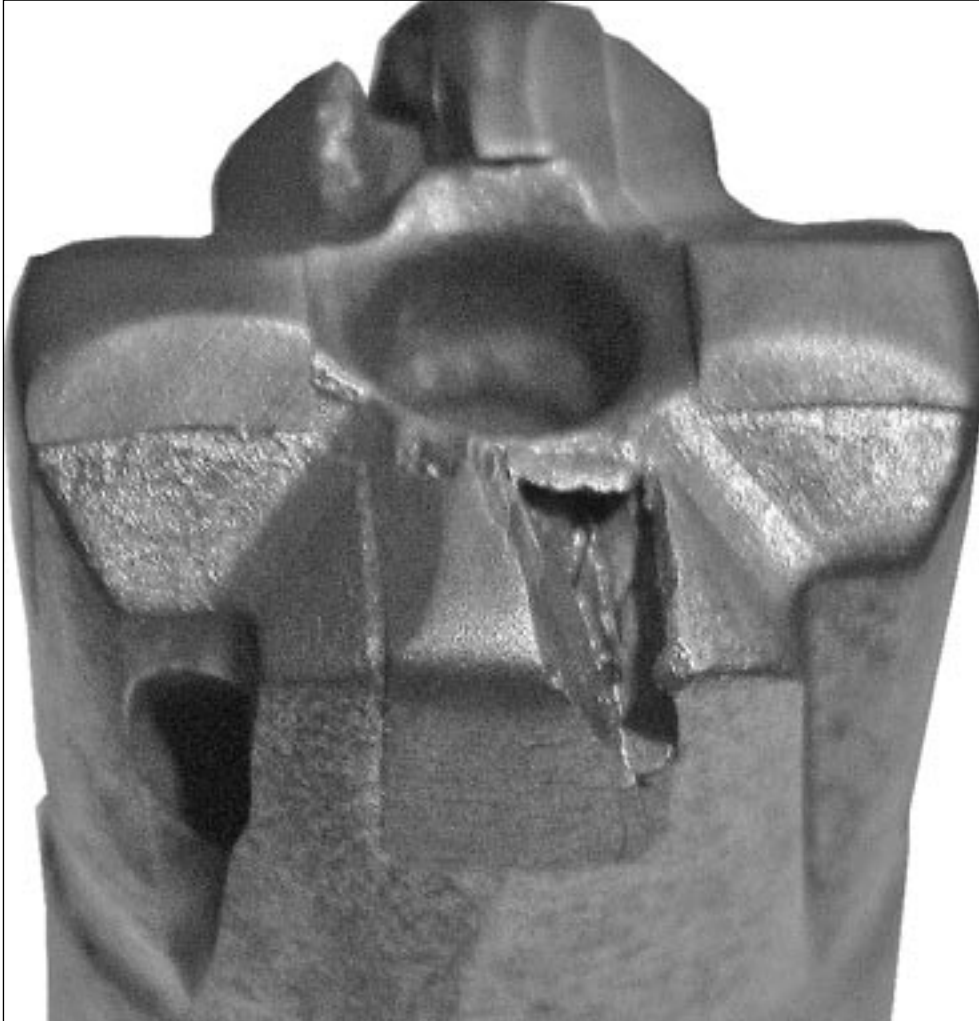
### **B:3 LONGITUDINAL CRACKS**

| Failure mode | Probable cause | Recommended action |
|---|---|---|
| <b>B:3 LONGITUDINAL CRACKS</b><br><br><i>Error code S5</i> | <p>Overheating from improper grinding</p> <p>Carbide grade too hard</p> | <p>Regrind bit to its original shape. Follow proper bit grinding procedures.</p> <p>Select a bit with a softer, tougher grade of carbide.</p> <p><i>Photograph »</i></p> |

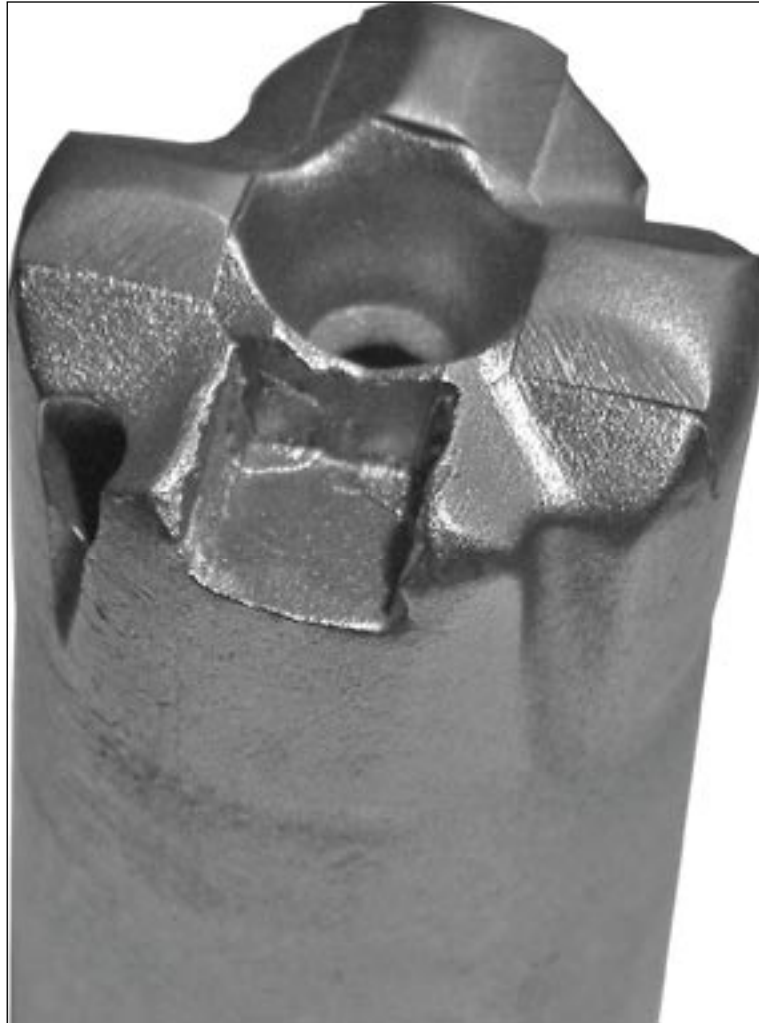
### **B:4 WHOLE INSERT LOST**

| Failure mode | Probable cause | Recommended action |
|---|---|---|
| <b>B:4 WHOLE INSERT LOST</b><br><br><i>Error code L1</i> | <p>Brazed joint fatigued</p> <p>Inadequate feed pressure</p> <p>Braze failure</p> | <p>Normal failure with long life.</p> <p>Increase feed pressure.</p> <p>Return for analysis.</p> <p><i>Photograph »</i></p> |

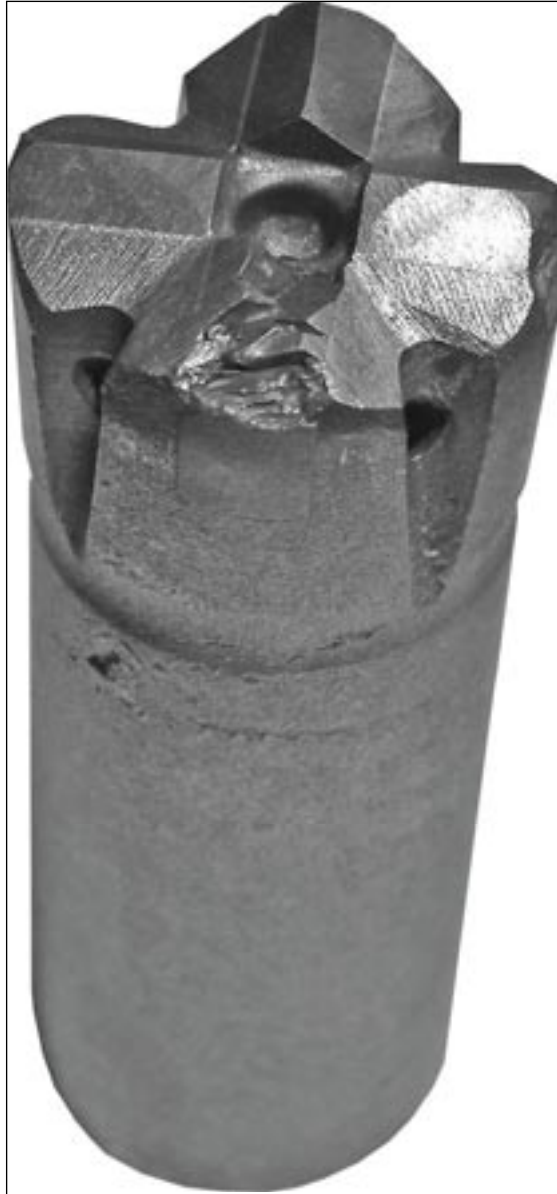
### B:6 INSERT CORNER FRACTURED

| Failure mode | Probable cause | Recommended action |
|---|---|---|
| <b>B:6 INSERT CORNER FRACTURED</b><br><br><i>Error code L2</i> | <p>Pinching by drilling into a hole that was drilled with a smaller bit</p> <p>Sharp corners or antitaper after grinding</p> <p>Removing a bit with a hammer or miner's wrench</p> <p>Drilling conditions creating snakeskin</p> <p>Bad collaring practices</p> | <p>Colour code bits by size to reduce the risk for negative gauge clearance.</p> <p>Ensure proper grinding procedures.</p> <p>Lower rotation and reduce hammer pressure.</p> <p>Early regrinding even if there are no wear flats.</p> <p>Reduce percussion and feed when collaring.</p> |

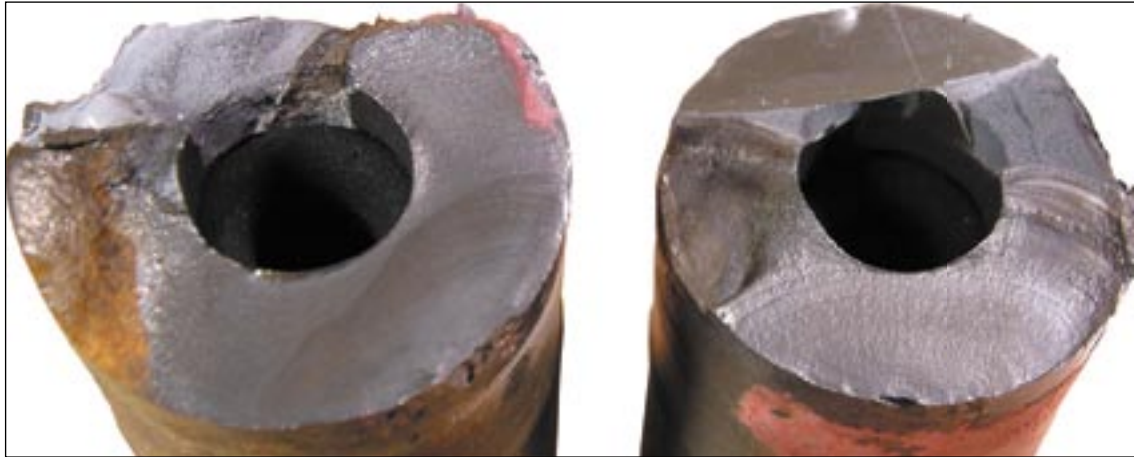
### C:1 SURFACE LAYER OF STEEL COMPROMISED BY A NICK OR DENT, FATIGUE ROSE ORIGINATING FROM THE SURFACE

| Failure mode | Probable cause | Recommended action |
|---|---|---|
| <b>C:1 SURFACE LAYER OF STEEL COMPROMISED BY A NICK OR DENT, FATIGUE ROSE ORIGINATING FROM THE SURFACE</b> <p>Error code Kxxu/Nxxu</p> | Surface damage caused by worn out centraliser bushings | Replace centraliser. |
| | Presence of a shiny steel surface near rose suggests martensite build up caused by rotation against steel | |
| | Using a sledge hammer on stuck steel | Use a rod wrench to loosen. |
| | Improper care and handling | Store rods in a rack when retracting drill string. Do not drop rods or store on the ground. |
| | Excessive feed | Monitor feed pressure and tune to rock conditions. |
| | Poor drilling conditions. Drilling in voids, seams and/or broken conditions | Adjust drilling pressures and tune to rock conditions. |
| | Feeder damaged when scaling in drifting and tunneling | Check feeder is not bent or twisted. |

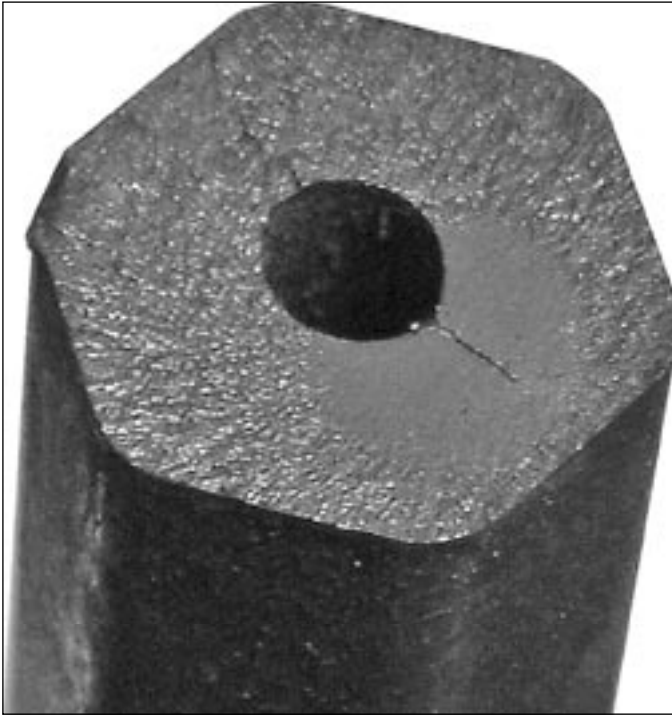
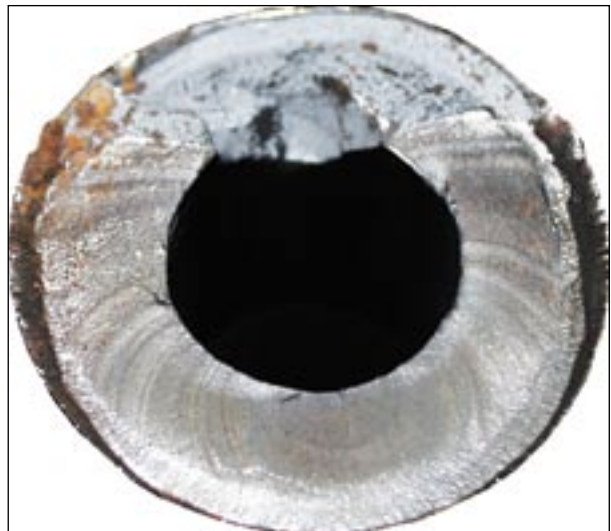
### C:2 ROD BREAKAGE CHARACTERISED BY A FATIGUE ROSE ORIGINATING FROM THE FLUSHING HOLE

| Failure mode | Probable cause | Recommended action |
|---|---|---|
| <b>C:2 ROD BREAKAGE CHARACTERISED BY A FATIGUE ROSE ORIGINATING FROM THE FLUSHING HOLE</b> | Corrosion caused by corrosive flushing agents | Ensure that proper storage practices are being followed.<br>Change components more frequently or neutralise flushing agent. |
| | Insufficient rust protection | Return for analysis. |

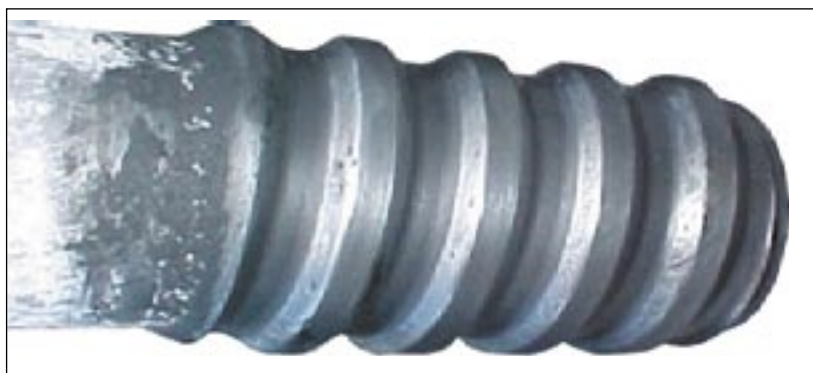
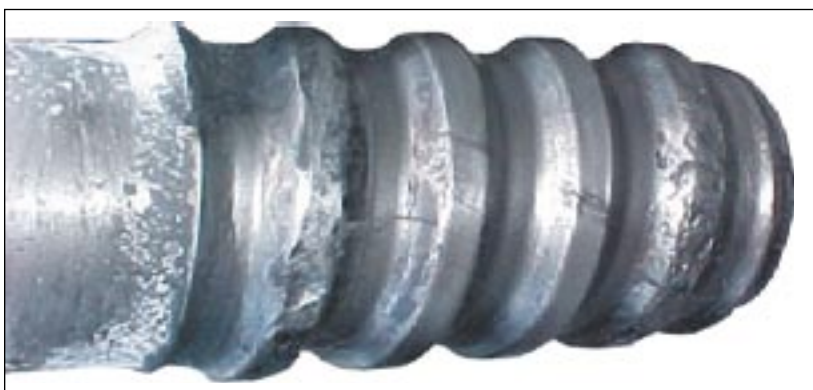
### C:3 PITTING OR WEAR IN HE THREADS

| <b>C:3 PITTING OR WEAR IN THE THREADS</b> | Overheated threads due to loose connection or hole deviation.<br>Reflected percussive energy | Tune percussion and feed pressures to conditions (in most cases reduce percussion pressure and increase feed pressure).<br>Use a ballistic button bit to help tighten drill string.<br>If caused by hole deviation take steps to drill straighter holes. |
| | Worn threads | Replace worn components. Do not put a worn rod on a new rod. Change all rods together. |

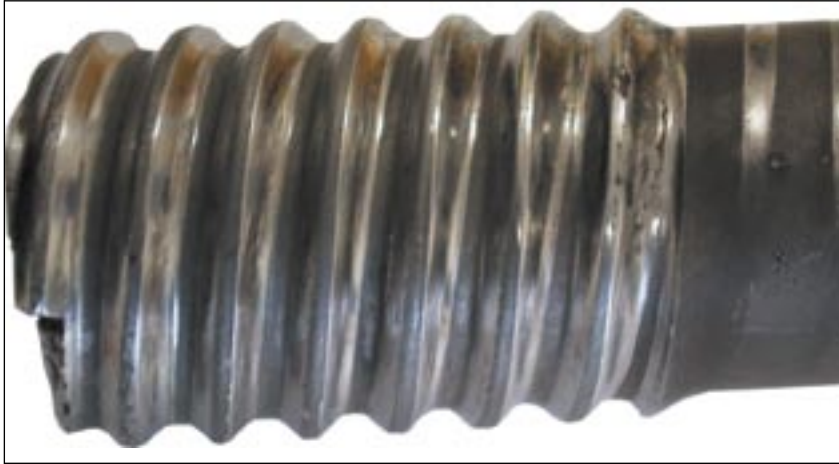
### C:5 CHIP BROKEN OFF MALE THREAD

| Failure mode | Probable cause | Recommended action |
|---|---|---|
| <b>C:5 CHIP BROKEN OFF MALE THREAD</b> <p>Error code B4</p> | <p>Inadequate feed pressure</p> <p>Worn coupling</p> <p>Misalignment of rods with extension. Steel hitting coupling shoulder</p> <p>Drilling with worn bits</p> <p>Corrosion fatigue due to corrosive flushing water</p> | <p>Adjust pressure to conditions.</p> <p>Replace worn components. Do not put a worn coupling on a new rod.</p> <p>Align drilling components with extension.</p> <p>Maintain button bits in time.</p> <p>Replace rod. Treat water.</p> |

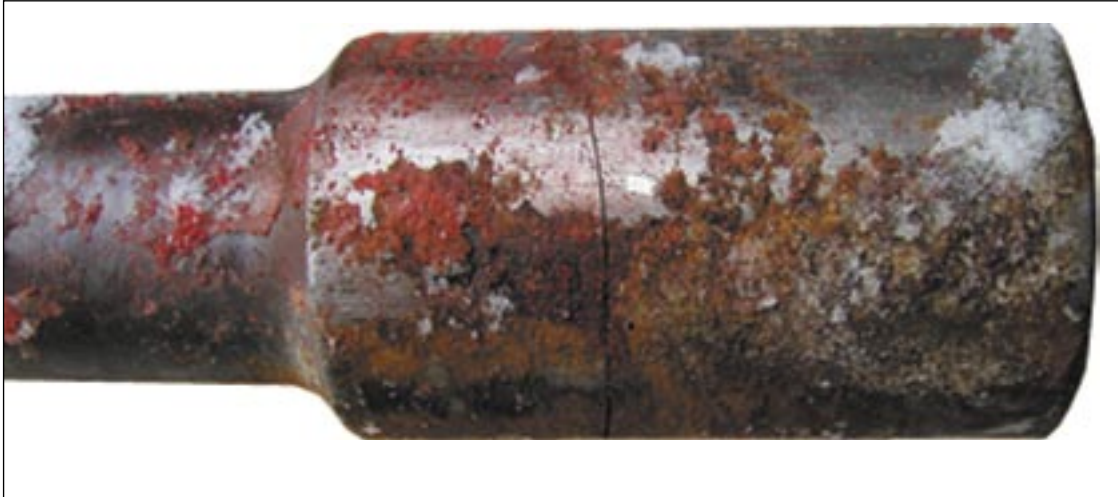
### C:6 FAILURE ACROSS FEMALE THREAD SECTION

| Failure mode | Probable cause | Recommended action |
|---|---|---|
| <b>C:6 FAILURE ACROSS FEMALE THREAD SECTION</b> | <p>Hole deviation or feed misalignment</p> <p>Inadequate feed pressure. Starting point pittings on thread</p> <p>High torque from drilling with worn bits</p> <p>Mismatching threads</p> <p>Nick or dent in steel surface</p> | <p>Employ guide tools and ballistic button bits.</p> <p>Monitor feed pressure and tune to conditions.</p> <p>Regrind the bit when the wear flats are 1/3 of the button diameter.</p> <p>Ensure all components are Sandvik manufactured. Do not "mix and match".</p> <p>Avoid hammering on connection. Use a wrench to loosen joints. Employ proper care and handling procedures.</p> |

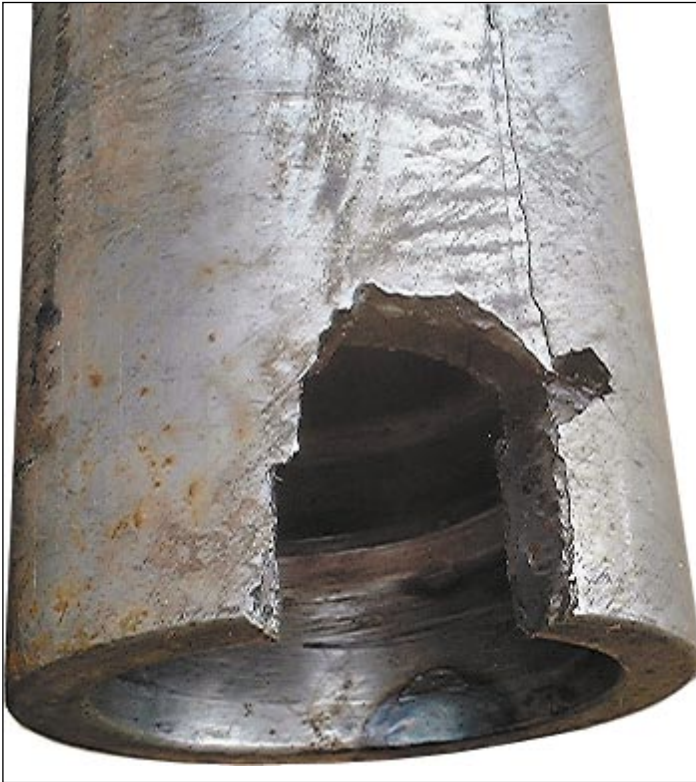
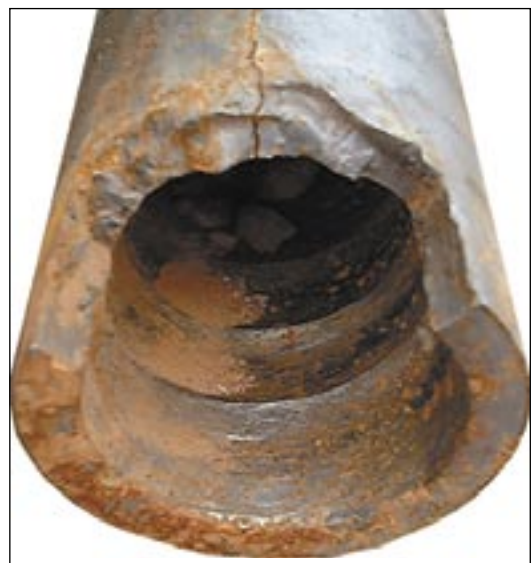
### C:7 FEMALE END IS CHIPPED, CRACKED AND/OR FLARED

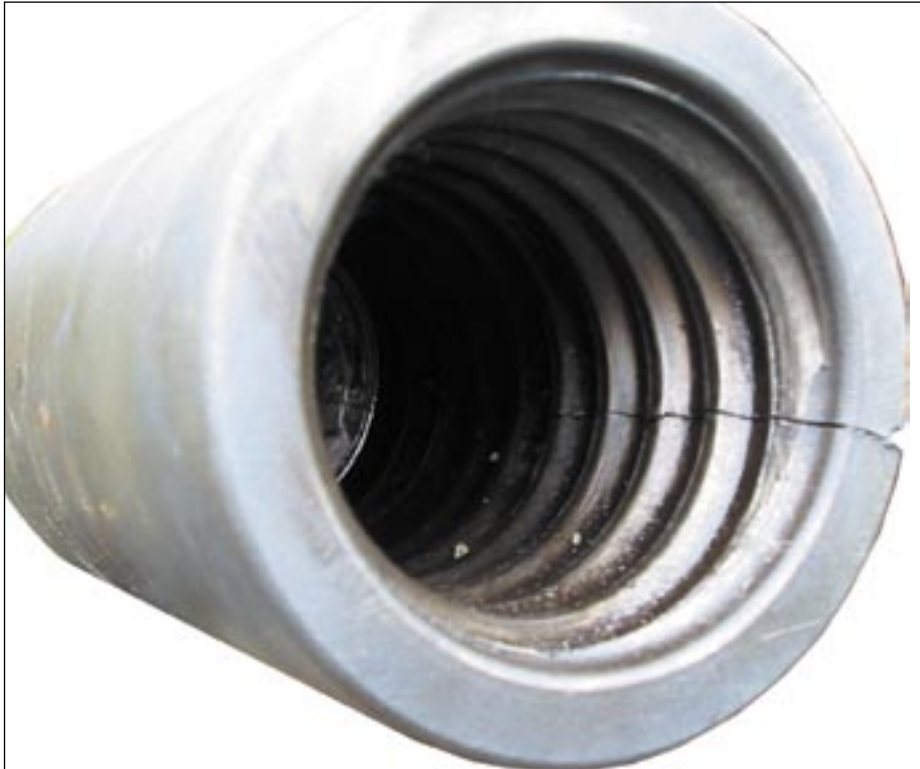
### C:8 LONGITUDINAL CRACK IN FEMALE CONNECTION

| Failure mode | Probable cause | Recommended action |
|---|---|---|
| <b>C:8 LONGITUDINAL CRACK IN FEMALE CONNECTION</b> | Worn out threads | Replace components in time. |
| | Drilling with loose thread joints | Increase the feed force.<br><br>Make sure that the joints are tightened before percussion.<br><br>Align drilling components with extension. |

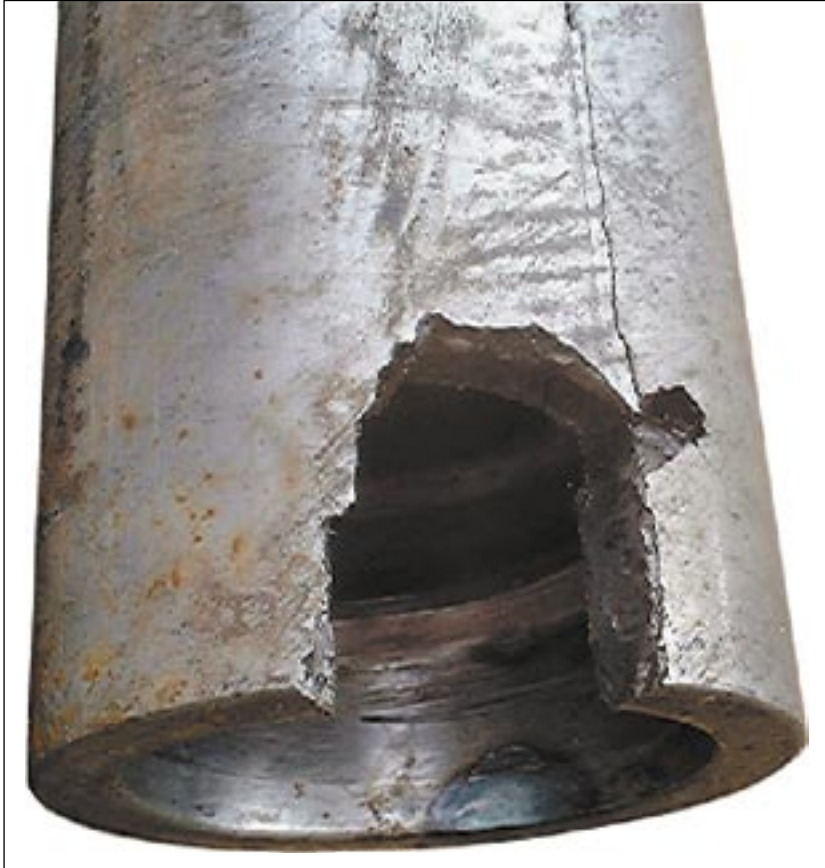
### D:1 FEMALE END IS CHIPPED, CRACKED AND/OR FLARED

| Failure mode | Probable cause | Recommended action |
|---|---|---|
| <b>D:1 FEMALE END IS CHIPPED, CRACKED AND/OR FLARED</b> | Thread joint not firmly tightened | Make sure threads are tight before engaging percussion. |

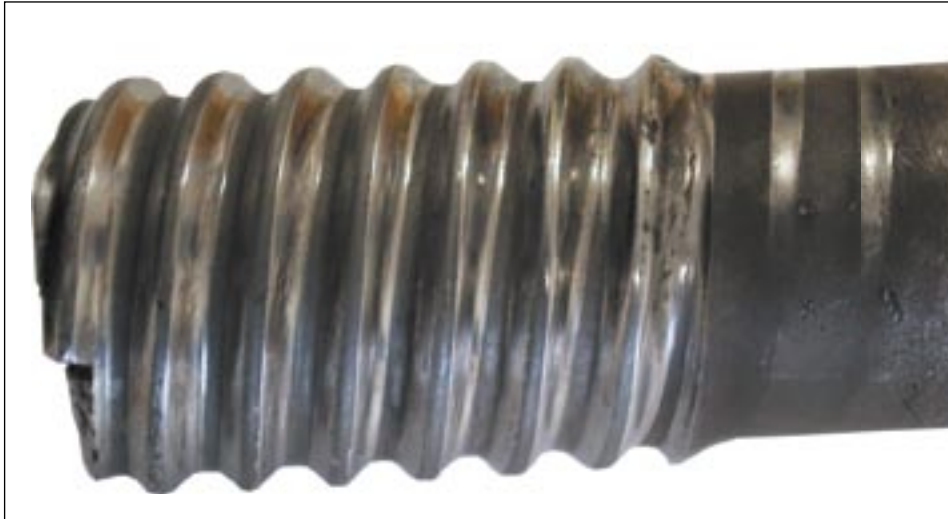
### D:2 FAILURE ACROSS MALE THREAD SECTION

| Failure mode | Probable cause | Recommended action |
|---|---|---|
| <b>D:2 FAILURE ACROSS MALE THREAD SECTION</b><br><br> | Inadequate feed pressure | Monitor feed pressure and tune to conditions. |
| | High torque caused by drilling with a worn bit | Regrind the bit when the wear flats are 1/3 of the button diameter. |
| | Worn threads | Replace worn components. |

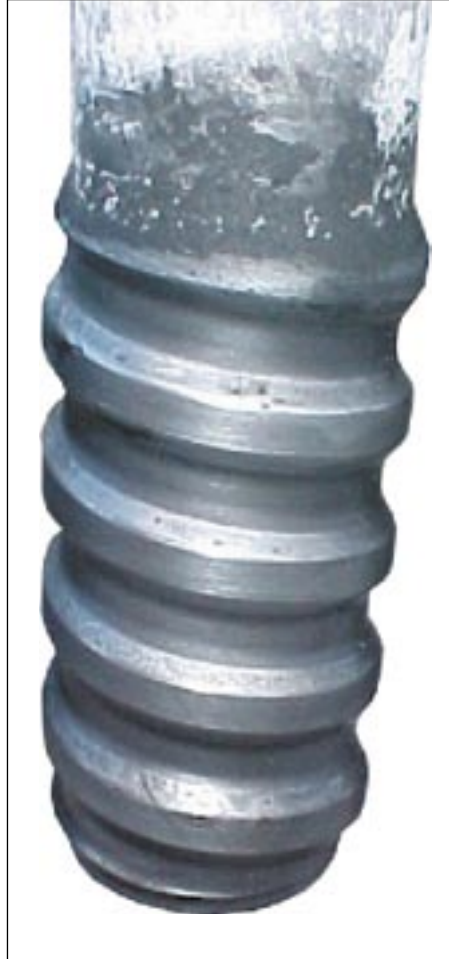
### D:3 PITTING OR WEAR IN THE THREADS

| <b>D:3 PITTING OR WEAR IN THE THREADS</b><br><br> | Reflected percussive energy | Adjust feed and percussion pressures to the rock conditions. |
| | Worn threads | Replace worn components. |
| | Drilling with worn bits | Regrind the bit when the wear flats are max. 1/3 of the button diameter. |

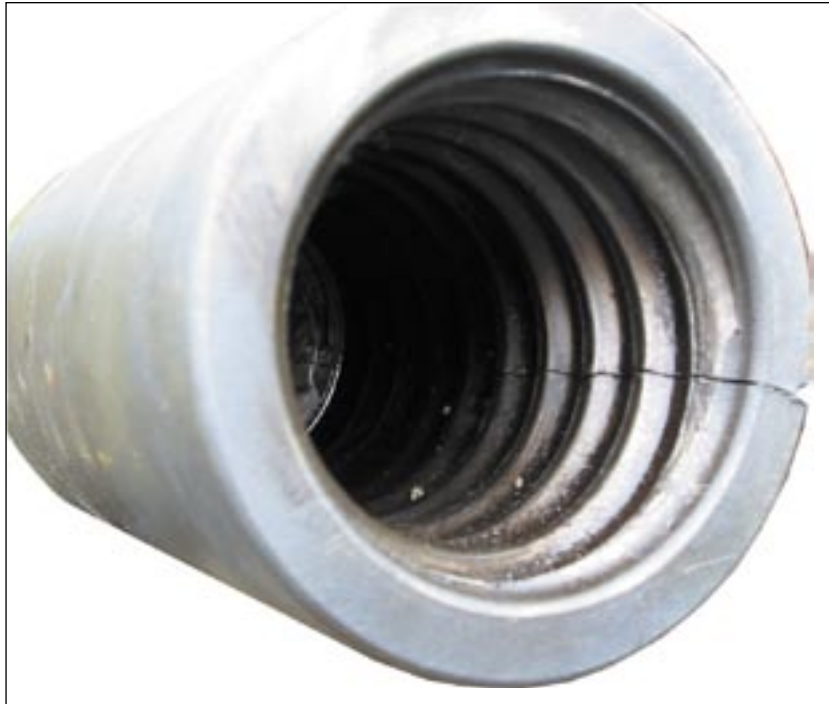
### D:4 LONGITUDINAL CRACK IN FEMALE CONNECTION

| Failure mode | Probable cause | Recommended action |
|---|---|---|
| <b>D:4 LONGITUDINAL CRACK IN FEMALE CONNECTION</b> | Worn out threads | Replace components in time. |
