# TOP HAMMER TOOLS **FAILURE ANALYSIS GUIDE**

# FAILURE ANALYSIS GUIDE

# ROCK DRILLING TOOLS FAILURE ANALYSIS GUIDE

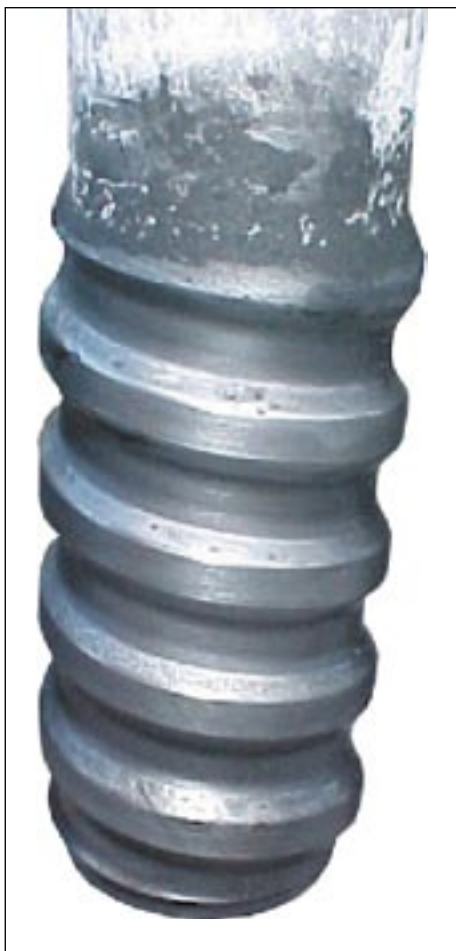
### E:1 PITTING OR WEAR ON THREADS

| Failure mode | Probable cause | Recommended action |
|---|---|---|
| <b>E:1 PITTING OR WEAR ON THREADS</b><br> <p>Error code A11</p> | <p>Inadequate feed pressure and/or high percussion</p> <p>Cuttings in thread</p> <p>Corrosion caused by corrosive flushing agents</p> | <p>Adjust machine settings.</p> <p>Keep flushing on when breaking pipe.</p> <p>Change components more frequently or neutralise flushing agent.</p> <p>Photograph »</p> |

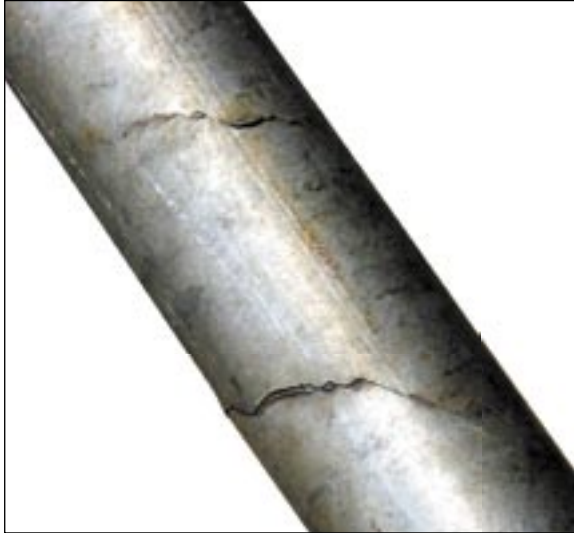
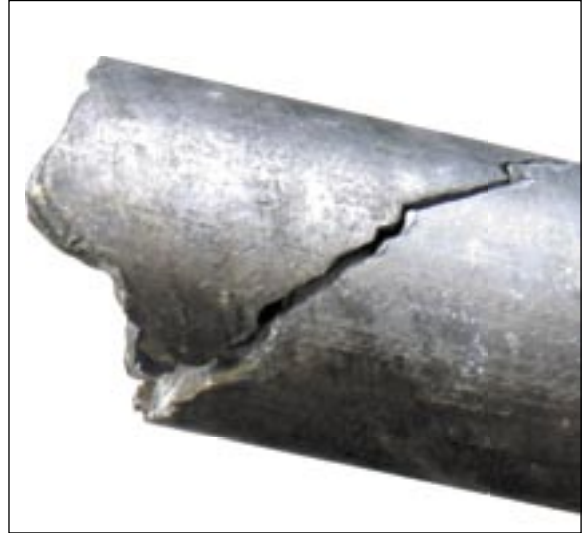
### E:4 BREAK IN TUBE

| Failure mode | Probable cause | Recommended action |
|---|---|---|
| <b>E:4 BREAK IN TUBE</b><br><br> <p>Error code B1</p> | <p>Friction martensite from worn out centraliser jaws</p> <p>Misalignment of feed</p> <p>Hole deviation</p> <p>Nick on tube</p> | <p>Change centraliser jaws.</p> <p>Make sure boom is aligned. Ensure good collaring practices.</p> <p>Employ Retractable bits with ballistic buttons.</p> <p>Ensure good rod handling practices.</p> |

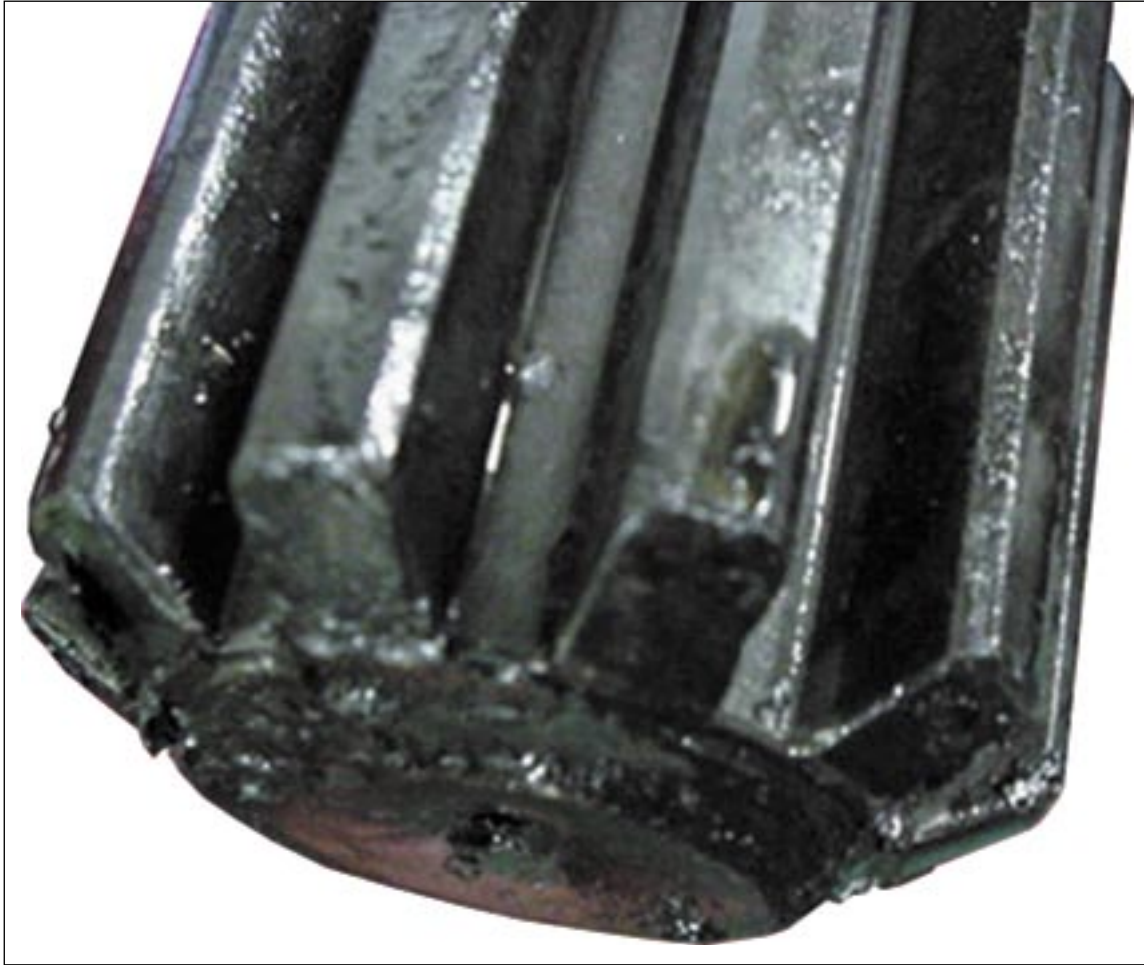
### F:1 IMPACT MARKS, CHIPPED OR RIVETED END

| Failure mode | Probable cause | Recommended action |
|---|---|---|
| <b>F:1 IMPACT MARKS, CHIPPED OR RIVETED END</b> | Misalignment due to worn out bushings<br>Damaged piston | Replace worn components in rock drill.<br>Replace piston.<br>Service affected equipment.<br>Service rock drill. |

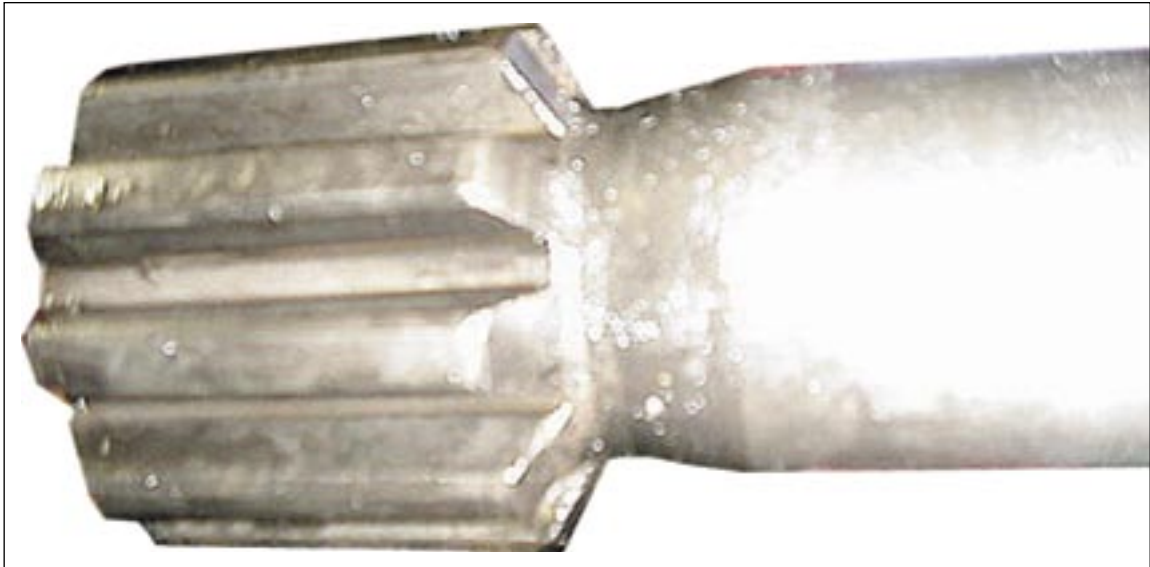
### F:3 WEAR IN BOTTOM OF SPLINE SHOULDER (common in bench drilling)

| Failure mode | Probable cause | Recommended action |
|---|---|---|
| <b>F:3 WEAR ON BOTTOM OF SPLINE SHOULDER (common in bench drilling)</b> | Excessive rotation when retracting string | Adjust rotation speed. |
| | Stuck rod in broken rock | Use Retrac bits and activate anti-jamming when drilling. Use a rock drill with power extractor. |

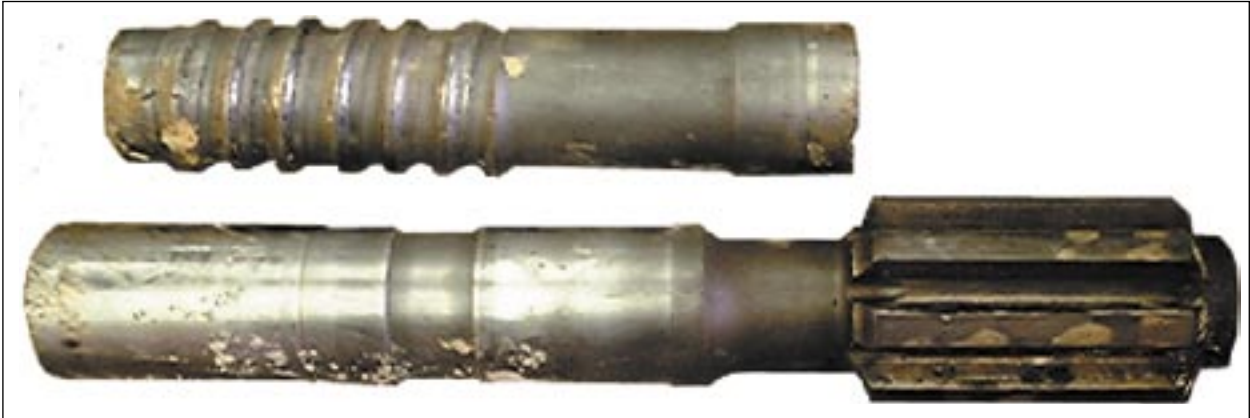
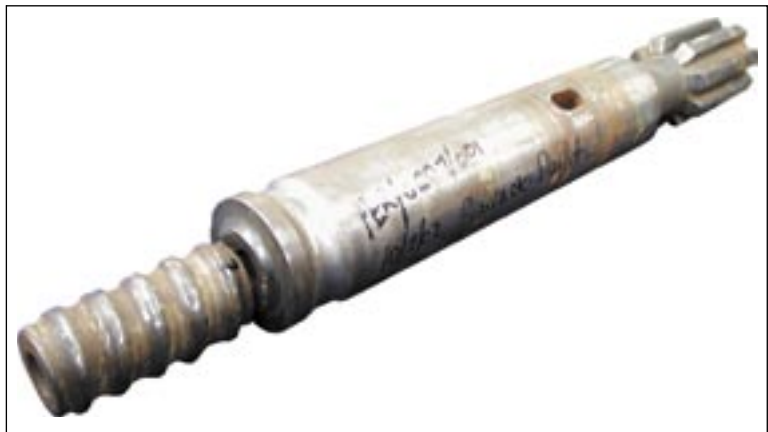
### F:4 FAILURE AT FRONT HEAD

| <b>F:4 FAILURE AT FRONT HEAD</b> | Misaligned boom | Ensure boom is aligned when drilling. |
| | Misalignment from worn front bushing | Replace worn components. |
| | Excessive feed | Reduce feed pressure, tune to rock conditions. |
