# TOP HAMMER TOOLS **FAILURE ANALYSIS GUIDE**

# FAILURE ANALYSIS GUIDE

# ROCK DRILLING TOOLS FAILURE ANALYSIS GUIDE

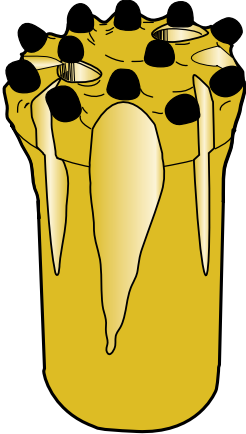
| Failure mode | Probable cause | Recommended action |
|---|---|---|
| <b>A:1 BODY WASH</b><br> | <p>Excessive flushing volume</p> <p>Drilling with excessive flushing volume can in some rock cause sand-blasting of the steel and too big protrusion and breakage of the buttons</p> | <p>Reduce flushing volume</p> <p>Shorten grinding intervals</p> <p>Photograph »</p> |

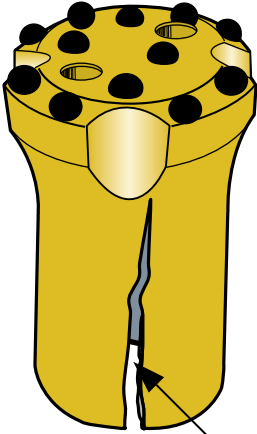
| Failure mode | Probable cause | Recommended action |
|---|---|---|
| <b>A:2 SPLIT SKIRT</b><br> <p>Error code B2</p> | <p>Drilling with the thread open</p> <p>Wrong procedure when loosening the bit</p> <p>Drilling with too worn threads</p> | <p>Increase feed force. Tighten joints before percussion.</p> <p>Loosen bit with impact mechanism while seated firmly on face or at bottom of hole. Use little feed and no rotation, or use special wrench.</p> <p>Change to new rods. Make sure specified rods are used.</p> <p>Photograph »</p> |

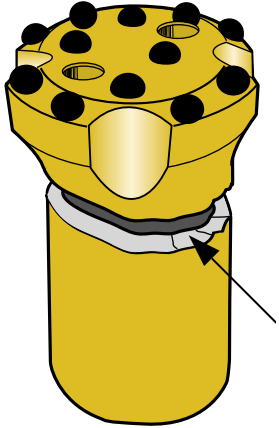
| Failure mode | Probable cause | Recommended action |
|---|---|---|
| <b>A:5 SKIRT RING-OFF</b><br><br><i>Error code B1</i> | <p>Excessive rotational speed applied to stuck bit</p> <p>Bad collaring practices</p> <p>Corrosion</p> <p>Hammering on bit to break connection</p> <p>Excessive back hammering</p> <p>Too low rock resistance</p> <p>Fatigue</p> | <p>Apply minimal amount of hammer pressure to free bit before increasing rotation speed.</p> <p>Reduce percussion and feed when collaring.</p> <p>Improve storage practices. Neutralise flushing agent.</p> <p>Loosen bit with impact mechanism while seated firmly against the rock. Use little feed and no rotation, or use special wrench.</p> <p>Use retrac bit.</p> <p>Reduce impact power.</p> <p>Normal failure with long life</p> <p>Photograph »</p> |

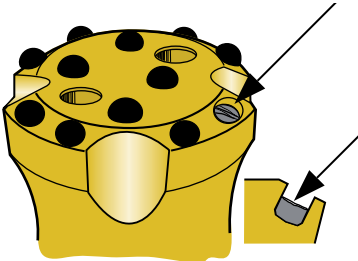
| Failure mode | Probable cause | Recommended action |
|---|---|---|
| <b>A:8 BUTTONS SHEARED-OFF UNDER BODY LEVEL</b><br><br>Error code S7u | <p>Excessive button protrusion through incorrect grinding or steel wash. Protrusion greater than 3/4 of the button diameter may not provide sufficient support to resist the tensile forces that the button may encounter.</p> <p>Incorrect size correlation between button and button hole</p> | <p>Shorten grinding intervals.</p> <p>Return for analysis.</p> <p><i>Photograph »</i></p> |

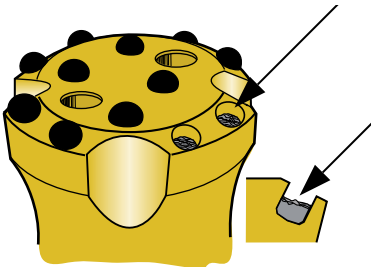
| Failure mode | Probable cause | Recommended action |
|---|---|---|
| <b>A:9 BUTTONS CRUSHED INSIDE THE BIT BODY</b><br><br>Error code S4u | <p>Bad collaring practices</p> <p>Anti-taper from abrasive rock</p> <p>Excessive button protrusion from incorrect grinding. Button protrusion greater than 3/4 of the button diameter will not provide sufficient support to resist the tensile forces that the buttons may encounter.</p> | <p>Ensure the boom is secure. Start collaring with reduced impact, then full pressure once bit is embedded 300 mm in the rock.</p> <p>Grind bit to original shape.</p> <p>Ensure correct grinding procedures.</p> <p><i>Photograph »</i></p> |

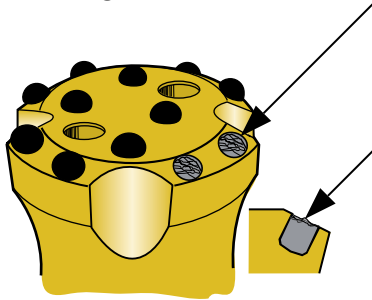
| Failure mode | Probable cause | Recommended action |
|---|---|---|
| <b>A:11 BUTTONS CRUSHED DOWN TO LEVEL OF BIT BODY</b><br><br><i>Error code S4</i> | <p>Snakeskin. Overdrilling in soft, non-abrasive rock leaves a shiny surface on the buttons and a fatigue in the surface of the cemented carbide, looking like snakeskin</p> <p>Overdrilling</p> <p>Incorrect grade of carbide</p> <p>Incorrect grinding procedures</p> | <p>Regularly inspect the bits and regrind regularly although the buttons seem not worn, just polished, to remove micro-cracks from the surface of the carbides.</p> <p>Shorten grinding intervals.</p> <p>Change carbide grade. See product catalogue or bit selection guide.</p> <p>Dry grinding can result in snakeskin fatigue. Employ wet grinding.</p> <p><i>Photograph »</i></p> |

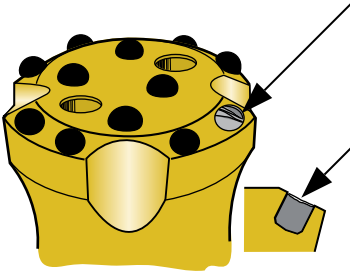
| Failure mode | Probable cause | Recommended action |
|---|---|---|
| <b>A:13 TOP OF BUTTON SHEARED OFF LEVEL WITH BODY</b><br><br><i>Error code S7</i> | <p>Overdrilling</p> <p>Drilling into metal</p> <p>Snakeskin</p> <p>Excessive button protrusion through incorrect grinding. Protrusions greater than 3/4 of the button diameter will not provide sufficient support to resist the tensile forces that the buttons may encounter.</p> | <p>Shorten grinding intervals. Regrind when the wear flats are max 1/3 of the button diameter.</p> <p>Ensure correct drilling practices.</p> <p>Regularly inspect the bits and grind to remove micro-cracks from the surface of the cemented carbide.</p> <p>Shorten grinding intervals.</p> <p><i>Photograph »</i></p> |

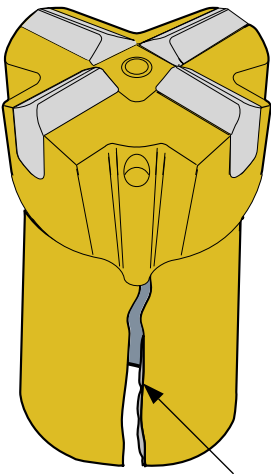
| Failure mode | Probable cause | Recommended action |
|---|---|---|
| <b>B:1 SPLIT SKIRT (taper bits)</b><br><br><i>Error code B2</i> | <p>Taper mismatch or worn taper</p> <p>Removing a bit with a hammer or miner's wrench</p> | <p>Use a taper gauge to check taper angle. Change to proper bits.</p> <p>Utilise a proper knock-off block when removing bit.</p> |

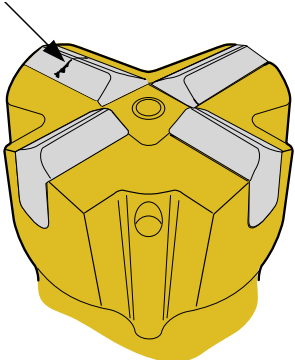
| Failure mode | Probable cause | Recommended action |
|---|---|---|
| <b>B:2 TRANSVERSAL CRACK</b><br><br><i>Error code S1</i> | <p>Overheating from improper grinding</p> <p>Anti-taper from abrasive rock</p> <p>Grinding scratches due to wrong grinding wheel</p> | <p>Regrind bit to its original shape. Follow proper bit grinding procedures.</p> <p>Shorten grinding intervals.</p> <p>Check grinding procedures and grinding wheel.</p> <p><i>Photograph »</i></p> |

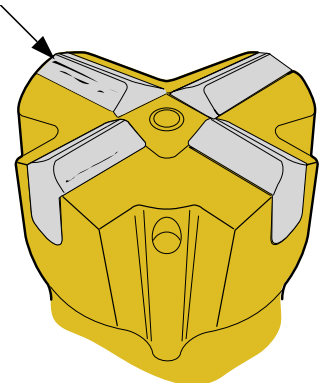
| Failure mode | Probable cause | Recommended action |
|---|---|---|
| <b>B:3 LONGITUDINAL CRACKS</b><br><br><i>Error code S5</i> | <p>Overheating from improper grinding</p> <p>Carbide grade too hard</p> | <p>Regrind bit to its original shape. Follow proper bit grinding procedures.</p> <p>Select a bit with a softer, tougher grade of carbide.</p> <p><i>Photograph »</i></p> |

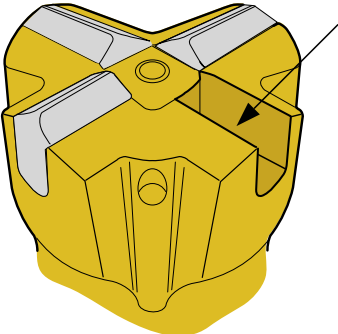
| Failure mode | Probable cause | Recommended action |
|---|---|---|
| <b>B:4 WHOLE INSERT LOST</b><br><br><i>Error code L1</i> | <p>Brazed joint fatigued</p> <p>Inadequate feed pressure</p> <p>Braze failure</p> | <p>Normal failure with long life.</p> <p>Increase feed pressure.</p> <p>Return for analysis.</p> <p><i>Photograph »</i></p> |

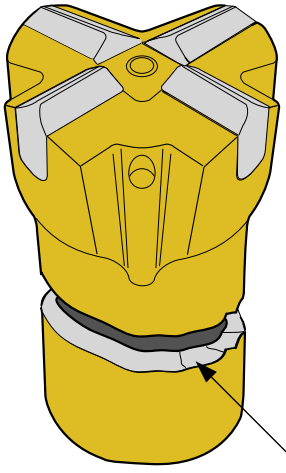
| Failure mode | Probable cause | Recommended action |
|---|---|---|
| <b>B:5 SKIRT RING-OFF (taper bits)</b><br><br><i>Error code B1</i> | <p>Taper mismatch or worn taper</p> <p>Drilling with a broken taper</p> <p>Removing a bit with a hammer or miner's wrench</p> <p>Spinning</p> <p>Excessive wear of the skirt (over-drilled bit)</p> | <p>Use a taper gauge to check taper angle. Change to proper bits.</p> <p>Change bit. Change to new drill steel and refurbish.</p> <p>Remove bit using correct knock-off tools.</p> <p>Adjust feed force.</p> |

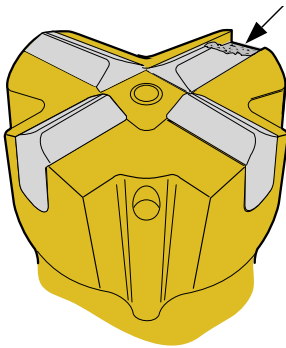
| Failure mode | Probable cause | Recommended action |
|---|---|---|
| <b>B:6 INSERT CORNER FRACTURED</b><br><br><i>Error code L2</i> | <p>Pinching by drilling into a hole that was drilled with a smaller bit</p> <p>Sharp corners or antitaper after grinding</p> <p>Removing a bit with a hammer or miner's wrench</p> <p>Drilling conditions creating snakeskin</p> <p>Bad collaring practices</p> | <p>Colour code bits by size to reduce the risk for negative gauge clearance.</p> <p>Ensure proper grinding procedures.</p> <p>Lower rotation and reduce hammer pressure.</p> <p>Early regrinding even if there are no wear flats.</p> <p>Reduce percussion and feed when collaring.</p> |

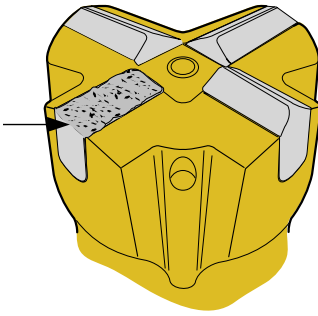
| Failure mode | Probable cause | Recommended action |
|---|---|---|
| <b>B:7 INSERT SHATTERED</b><br><br><i>Error code S4</i> | <p>Incorrect grade of carbide</p> <p>Insufficient flushing</p> <p>Improper grinding</p> | <p>Change carbide grade, see product catalogue.</p> <p>Increase flushing pressure.</p> <p>Ensure proper grinding procedures.</p> |

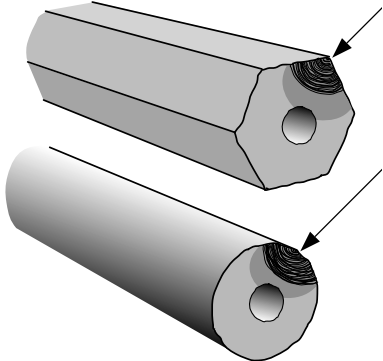
| Failure mode | Probable cause | Recommended action |
|---|---|---|
| <b>C:1 SURFACE LAYER OF STEEL COMPROMISED BY A NICK OR DENT, FATIGUE ROSE ORIGINATING FROM THE SURFACE</b> <p>Error code Kxxu/Nxxu</p> | Surface damage caused by worn out centraliser bushings | Replace centraliser. |
| | Presence of a shiny steel surface near rose suggests martensite build up caused by rotation against steel | |
| | No centraliser used | Ensure proper maintenance of rig. |
| | Using a sledge hammer on stuck steel | Use a rod wrench to loosen. |
| | Improper care and handling | Store rods in a rack when retracting drill string. Do not drop rods or store on the ground. |

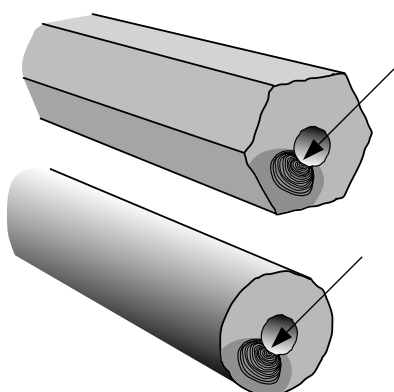
Error code Kxxi/Nxxi

| Failure mode | Probable cause | Recommended action |
|---|---|---|
| <b>C:2 ROD BREAKAGE CHARACTERISED BY A FATIGUE ROSE ORIGINATING FROM THE FLUSHING HOLE</b> | Corrosion caused by corrosive flushing agents | Ensure that proper storage practices are being followed.<br>Change components more frequently or neutralise flushing agent. |
| | Insufficient rust protection | Return for analysis. |
| | Pores in flushing hole surface | Return for analysis. |

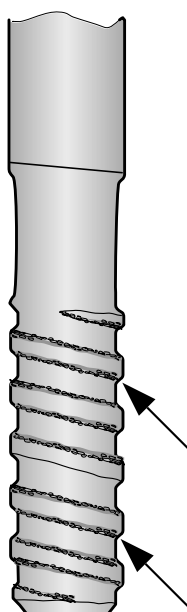
Error code A11

| <b>C:3 PITTING OR WEAR IN THE THREADS</b> | Overheated threads due to loose connection or hole deviation.<br>Reflected percussive energy | Tune percussion and feed pressures to conditions (in most cases reduce percussion pressure and increase feed pressure).<br>Use a ballistic button bit to help tighten drill string.<br>If caused by hole deviation take steps to drill straighter holes. |
| | Free hammering | Do not engage full percussion unless the bit is firmly seated against rock. Use reduced percussion when collaring on uneven surfaces. |
| | Worn threads | Replace worn components. Do not put a worn rod on a new rod. Change all rods together. |

Drilling with worn bits

Regrind the bit when the wear flats are max. 1/3 of the button diameter.

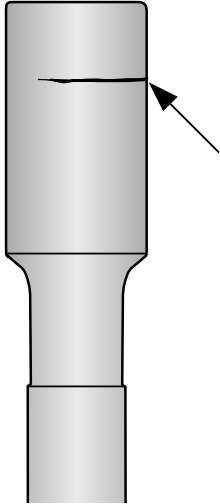
Error code B1

| Failure mode | Probable cause | Recommended action |
|---|---|---|
| <b>C:6 FAILURE ACROSS FEMALE THREAD SECTION</b> | <p>Hole deviation or feed misalignment</p> <p>Inadequate feed pressure. Starting point pittings on thread</p> <p>High torque from drilling with worn bits</p> <p>Mismatching threads</p> <p>Nick or dent in steel surface</p> | <p>Employ guide tools and ballistic button bits.</p> <p>Monitor feed pressure and tune to conditions.</p> <p>Regrind the bit when the wear flats are 1/3 of the button diameter.</p> <p>Ensure all components are Sandvik manufactured. Do not "mix and match".</p> <p>Avoid hammering on connection. Use a wrench to loosen joints. Employ proper care and handling procedures.</p> |

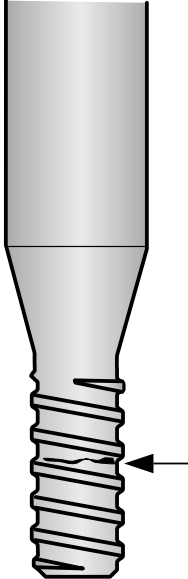
Error code Kxx

| Failure mode | Probable cause | Recommended action |
|---|---|---|
| <b>D:2 FAILURE ACROSS MALE THREAD SECTION</b><br><br> | Inadequate feed pressure | Monitor feed pressure and tune to conditions. |
| | Breakage starting from pitting on thread | See D:3 below. |
| | High torque caused by drilling with a worn bit | Regrind the bit when the wear flats are 1/3 of the button diameter. |
| | Worn threads | Replace worn components. |

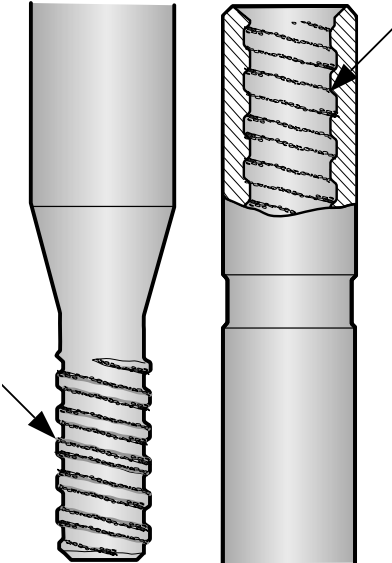
| <b>D:3 PITTING OR WEAR IN THE THREADS</b><br><br> | Reflected percussive energy | Adjust feed and percussion pressures to the rock conditions. |
| | Free hammering | Do not engage full percussion unless the bit is firmly seated against rock. Use reduced percussion when collaring on uneven surfaces. |
| | Worn threads | Replace worn components. |
| | Drilling with worn bits | Regrind the bit when the wear flats are max. 1/3 of the button diameter. |

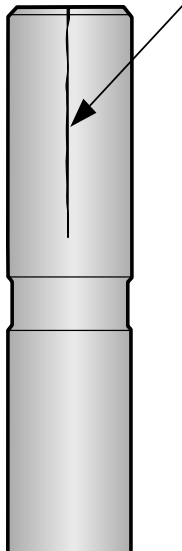
Error code B2

| Failure mode | Probable cause | Recommended action |
|---|---|---|
| <b>D:4 LONGITUDINAL CRACK IN FEMALE CONNECTION</b> | Worn out threads | Replace components in time. |
| | Misalignment of rods. Steel hitting coupling shoulder | Service affected equipment. |
| | Hammering with open threads gives wedging effect which can split the coupling | Always make sure that connection is tight before hammering.<br>Avoid excessive back hammering. |

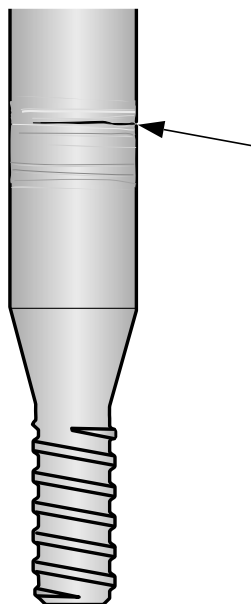
Error code Kxx/Nxx/B1

Surface damage caused by worn out centralisers

Nick or dent in steel surface

Replace centralisers.

Avoid hammering on the tube.  
Employ proper care and handling.

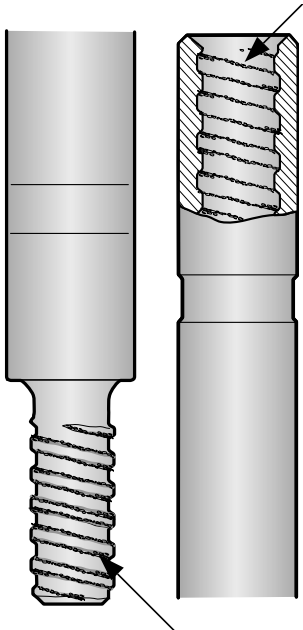
| Failure mode | Probable cause | Recommended action |
|---|---|---|
| <b>E:1 PITTING OR WEAR ON THREADS</b><br> <p>Error code A11</p> | <p>Inadequate feed pressure and/or high percussion</p> <p>Cuttings in thread</p> <p>Corrosion caused by corrosive flushing agents</p> | <p>Adjust machine settings.</p> <p>Keep flushing on when breaking pipe.</p> <p>Change components more frequently or neutralise flushing agent.</p> <p>Photograph »</p> |

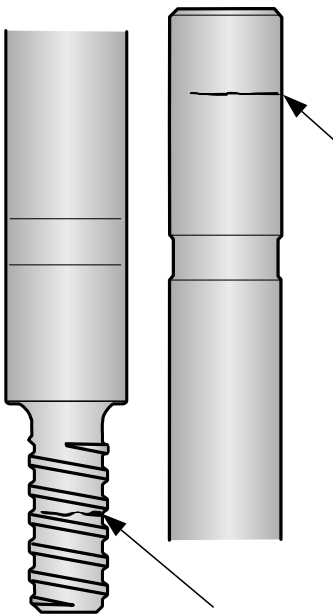
| Failure mode | Probable cause | Recommended action |
|---|---|---|
| <b>E:2 FAILURE IN MALE OR FEMALE THREAD SECTION</b><br> <p>Error code Kxx/Nxx</p> | <p>Misalignment of feed</p> <p>Hole deviation</p> <p>Hit on thread</p> <p>Corrosion caused by corrosive flushing agents</p> | <p>Make sure boom is aligned. Ensure good collaring practices.</p> <p>Employ Retrac bits with ballistic buttons.</p> <p>Ensure good rod handling practices.</p> <p>Change components more frequently or neutralise flushing agent.</p> <p>Photograph »</p> |

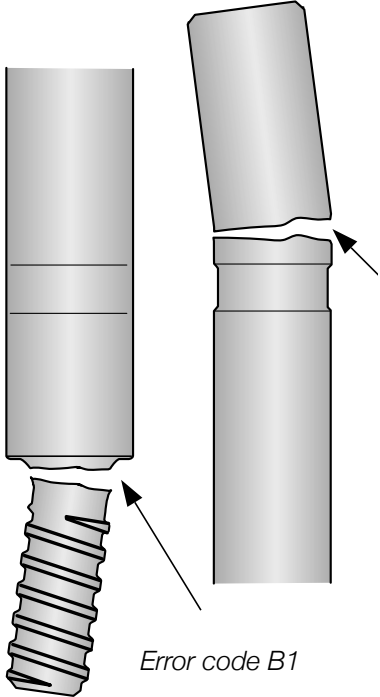
| Failure mode | Probable cause | Recommended action |
|---|---|---|
| <b>E:3 BREAK IN THREAD CLEARANCE</b><br><br> <p>Error code B1</p> | <p>Corrosion caused by corrosive flushing agents</p> <p>Misalignment of tube during friction welding</p> | <p>Change components more frequently or neutralise flushing agent.</p> <p>Return for analysis.</p> |

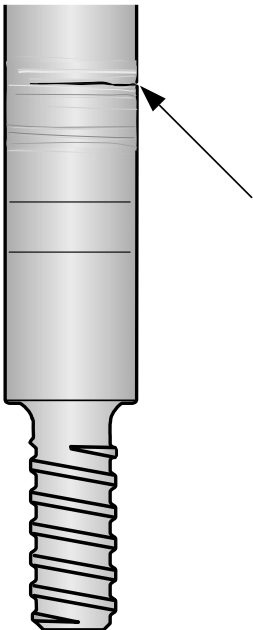
| Failure mode | Probable cause | Recommended action |
|---|---|---|
| <b>E:4 BREAK IN TUBE</b><br><br> <p>Error code B1</p> | <p>Friction martensite from worn out centraliser jaws</p> <p>Misalignment of feed</p> <p>Hole deviation</p> <p>Nick on tube</p> | <p>Change centraliser jaws.</p> <p>Make sure boom is aligned. Ensure good collaring practices.</p> <p>Employ Retractable bits with ballistic buttons.</p> <p>Ensure good rod handling practices.</p> |

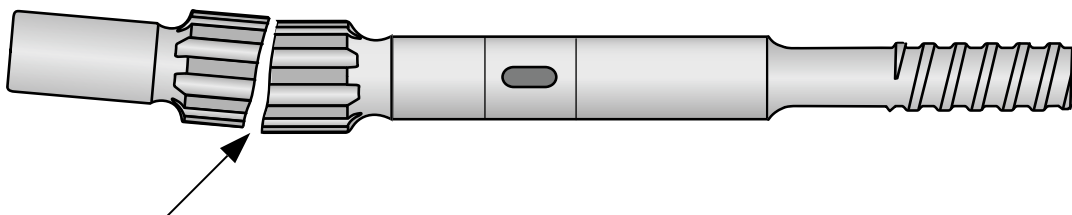
Error code Nxx

| <b>F:2 FAILURE ACROSS SPLINES</b> | Poor or no lubrication | Ensure functioning lubrication |
| | Stuck rod in broken rock and/or excessive back hammering | Use Retrac bits and activate anti-jammig when drilling. |
| | Worn out chuck coupling | Replace worn components. |
| | Overdrilling bits | Regrinding should be done when the wear flats are max. 1/3 of the button diameter. |
| | Inadequate feed pressure | Monitor coupling temperatures and adjust feed pressures according to recommendations. |

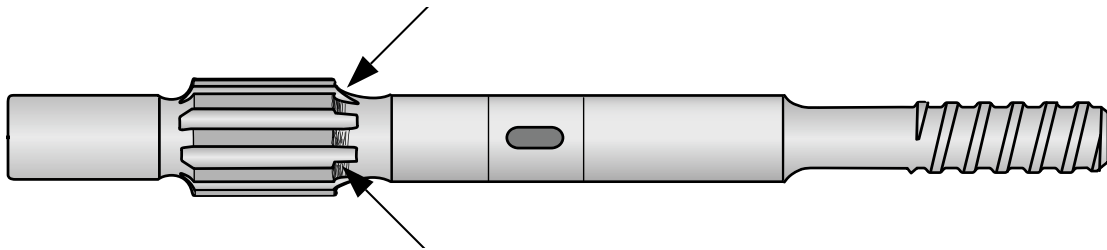
| Failure mode | Probable cause | Recommended action |
|---|---|---|
| <b>F:3 WEAR ON BOTTOM OF SPLINE SHOULDER (common in bench drilling)</b> | Excessive rotation when retracting string | Adjust rotation speed. |
| | Stuck rod in broken rock | Use Retrac bits and activate anti-jamming when drilling. Use a rock drill with power extractor. |

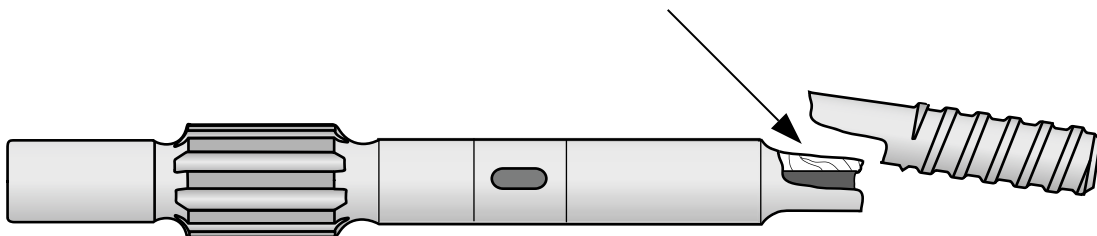
| <b>F:4 FAILURE AT FRONT HEAD</b> | Misaligned boom | Ensure boom is aligned when drilling. |
| | Misalignment from worn front bushing | Replace worn components. |
| | Excessive feed | Reduce feed pressure, tune to rock conditions. |

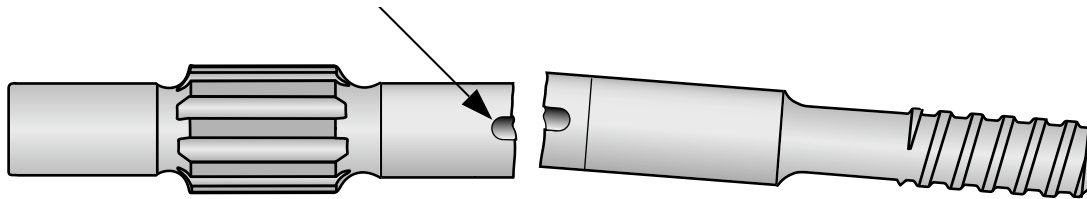
| Failure mode | Probable cause | Recommended action |
|---|---|---|
| <b>F:7 CORROSION</b> | Corrosion from corrosive flushing agent | Replace broken/damaged components. Change or neutralize flushing agent. |
| | Dirty flushing water | Clean water of solids. Use large water basins or install filters. |
| | Fatigue | Replace more frequent |

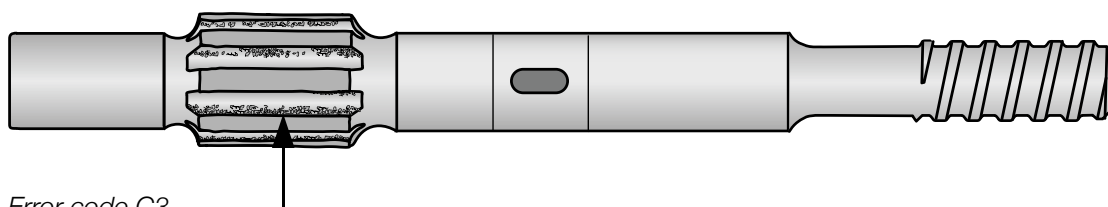
| Failure mode | Probable cause | Recommended action |
|---|---|---|
| <b>F:9 PITTING AND GALLING ON SPLINES</b> | Poor or missing lubrication | Make sure that rock drill is receiving sufficient lubrication |
| | Excessive rotation in soft or broken ground | Adjust drilling pressures. |
| | Incorrect shank lubrication oil | Change to recommended oil. |
| | Hydraulic oil is too hot | Equip rig with a cooling unit. |
| | Stuck rod in broken rock and/or excessive back hammering | Use Retractable bits and activate anti-jamming when drilling. Use a rock drill with power extractor. |

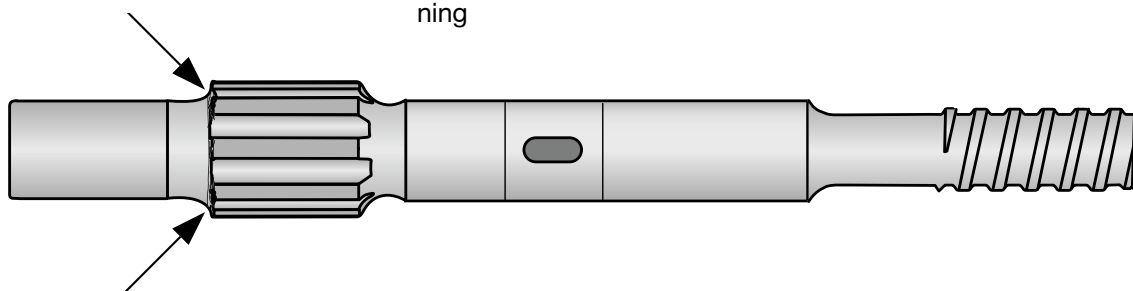
| <b>F:10 EXCESSIVE WEAR ON TOP OF SPLINE SHOULDER</b> | Inadequate feed pressure | Adjust feed pressure according to recommendations. |
| | Worn-out rotation bushing | Change bushing. |
| | Damping piston is not functioning | Repair damping piston. |

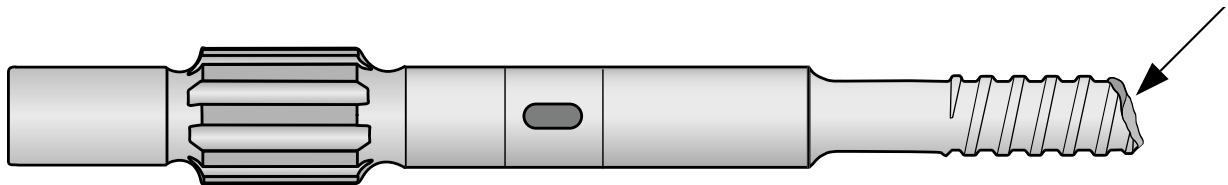
| Failure mode | Probable cause | Recommended action |
|---|---|---|
| <b>F:11 CHIPPED THREAD END</b> | Adapter dropped into coupling<br>Machine cradle is too loose<br>Misalignment of boom | Inspect feed for misalignment.<br>Secure good alignment. |
| | Adapter not properly coupled to<br>drill steel. | Replace worn-out couplings.<br>Use new couplings with new<br>shank adapters. |
| | Broken drill rod | Replace rod. |
| | Drill steel end not square | Check alignment or hole deviation. |

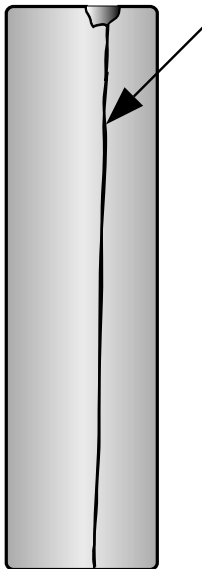
| Failure mode | Probable cause | Recommended action |
|---|---|---|
| <b>G:2 LONGITUDINAL CRACK</b><br><br> | Drilling with loose thread joints | Increase the feed force. Make sure that the joints are tightened before percussion. Avoid excessive back hammering. |
| | Back rotation with percussion | Do not back rotate. |
| | Nick or dent in steel surface | Avoid hammering on connection. Rotate loose or use a wrench to loosen joints. Employ proper care and handling. |
| | Worn-out sleeve | Change sleeve. |

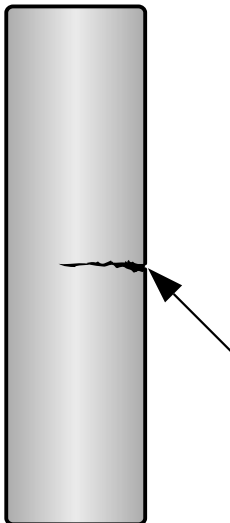
| <b>G:3 TRANSVERSAL CRACK</b><br><br> | Nick or dent in steel surface | Avoid hammering on connection. Rotate loose or use a wrench to loosen joints. Employ proper care and handling. |
| | Worn-out sleeve | Change sleeve. |
| | Hole deviation or feed misalignment | Employ guide tools and ballistic button bits. |
| | Inadequate feed pressure | Monitor feed force and tune to conditions. |
| | Heavy rotational loads from drilling with worn bits | Regrind the bit when the wear flats are max. 1/3 of the button diameter. |

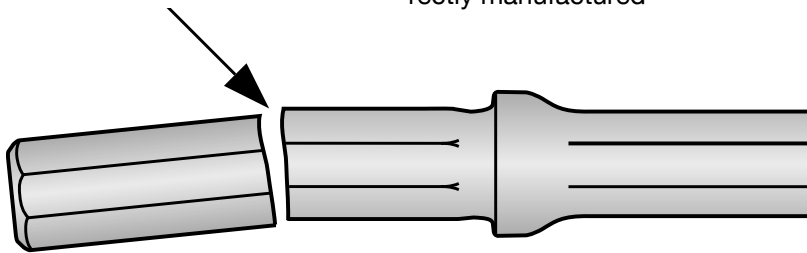
| Failure mode | Probable cause | Recommended action |
|---|---|---|
| <b>H:1 FAILURE IN THE SHANK END</b> | Worn chuck bushing | Replace worn bushing. |
| | Lack of or improper lubrication | Check that adequate volume of shank lubrication oil is reaching the shank. |
| | Excessive feed pressure. | Reduced feed pressure. |
| | Flushing hole in shank incorrectly manufactured | Return for analysis. |

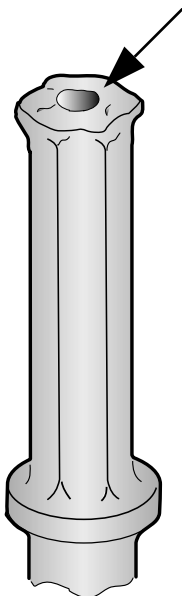
| <b>H:2 STRIKING FACE DEFORMED</b> | Worn chuck bushing | Replace worn bushing. |
| | Damaged piston | Replace piston. |
| | High operating pressures | Adjust to rock conditions. |
| | Hardness heat treatment not to specification | Return for analysis. |

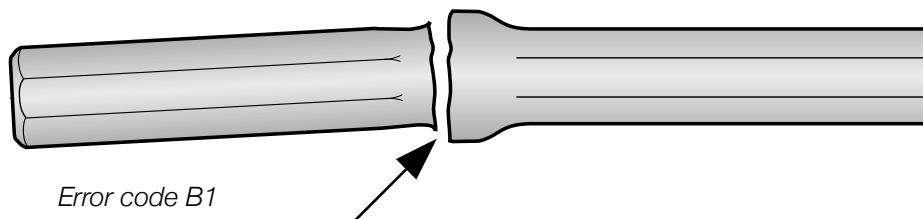
| Failure mode | Probable cause | Recommended action |
|---|---|---|
| <b>H:3 WEAR OR BREAKAGE AT BEGINNING OF COLLAR RADIUS</b> | Indentation of the collar by chuck bushing | Replace worn bushing.<br>Ensure that Sandvik parts are used. |
| | Worn chuck bushing | Replace worn bushing. |
| | Incorrect radius in transition between collar and shank | Return for analysis. |

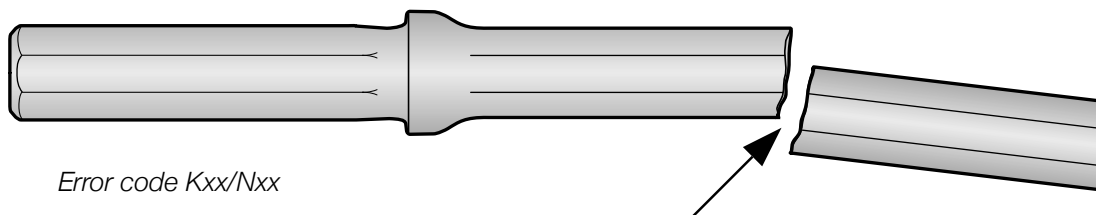
| <b>H:4 BREAKAGE IN ROD SECTION</b> | Drilling with bent rod | Keep rod aligned. |
| | Surface damaged | Review handling routines. |
| | Hit at corners | Do not hit rods when stuck in hole. |

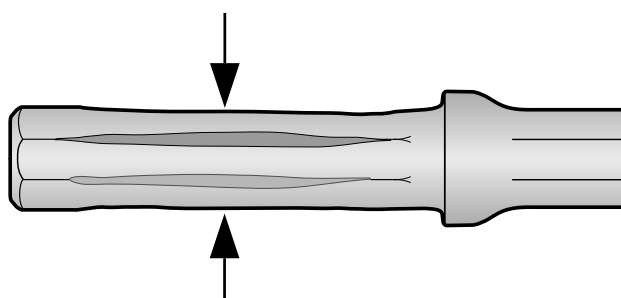
| <b>H:5 SHANK WEAR OR COKE BOTTLE WEAR</b> | Worn chuck bushing | Replace worn bushing. |

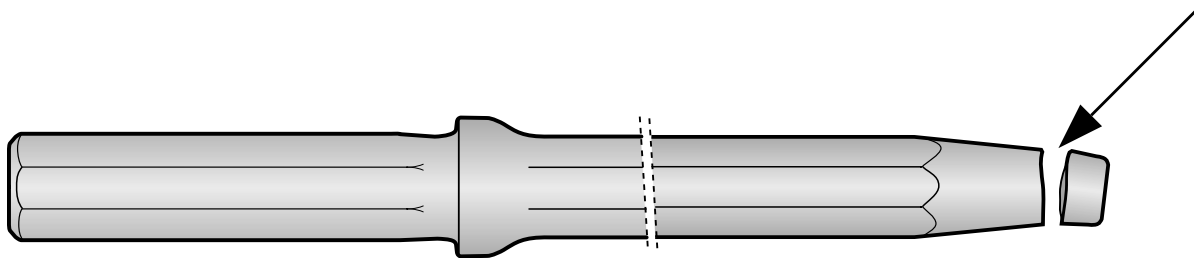
| Failure mode | Probable cause | Recommended action |
|---|---|---|
| <b>H:6 BREAKAGE ON TAPER RADIUS</b> | Worn bit socket. | Change bit. |
| | Using a damaged bit with a ridge or lip within the socket. | Change bit or ream out ridge. |
| | Spinning | Adjust feed force. Use Sandvik bits, do not "mix and match". Use bit with a symmetrical button design. |

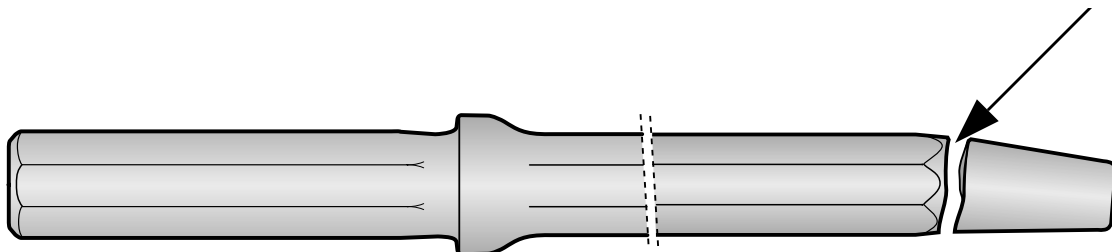
| <b>H:7 BREAKAGE CLOSE TO BIT END</b> | Drilling through the bottom of blocks. | Improve working practices. |
| | Excessive gauge wear on gauge | Reduce service life. Resharpen bit when wear flats are greater than 1/3 of button diameter |
| | Broken from flushing hole | Return for analysis. |

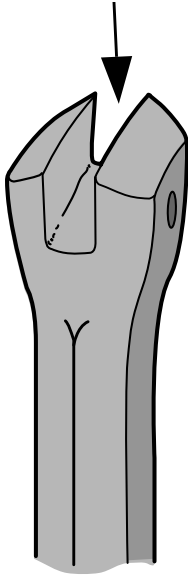
### H:8 FAILURE IN THE JOINT

Poor brazing

Return for analysis.

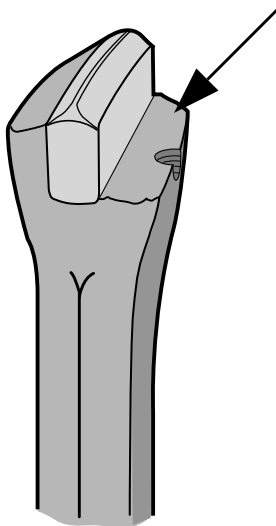
### H:9 FAILURE IN THE WING

Quality issue

Return for analysis.

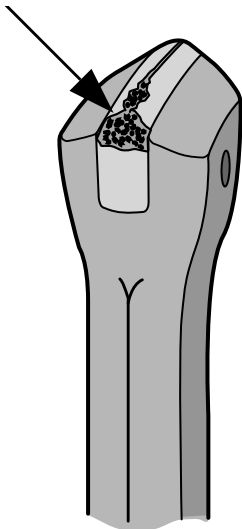
| Failure mode | Probable cause | Recommended action |
|---|---|---|
| <b>H:10 FAILURE IN THE CARBIDE</b><br> <p>Error code S</p> | <p>Improper grinding - too sharp insert corners</p> <p>Overheating insert when resharp-<br/>pening.</p> <p>Drilling conditions creating sna-<br/>keskin</p> <p>Antitaper</p> | <p>Follow grinding instructions</p> <p>Resharpen insert to its original shape. Follow proper grinding procedures and use correct grind-<br/>ing wheel.</p> <p>Lower rotation and reduce ham-<br/>mer pressure. Early regrinding even if no wear flats.</p> <p>Employ proper grinding routines</p> |

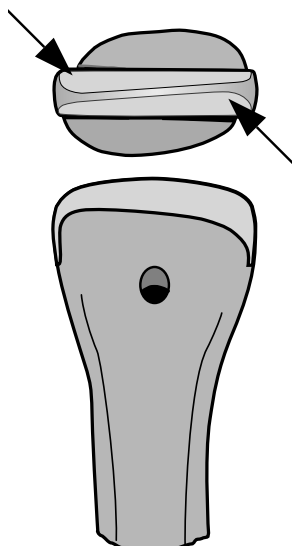
### H:11 PROPELLER WEAR

Poor flushing

Poor rotation

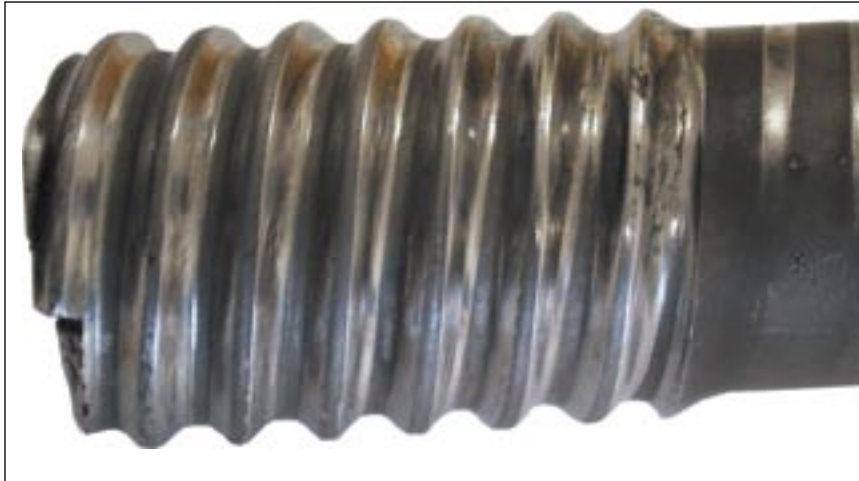
### F:5 FAILURE IN THREADS

| Failure mode | Probable cause | Recommended action |
|---|---|---|
| <b>F:5 FAILURE IN THREADS</b> <p>Error code Kxx</p> | Drilling with open threads causing heat and pittings on thread | Adjust settings to balance impact, feed and rotation |
| | Poor drilling conditions | Adjust drilling pressures and tune to rock conditions. Use Retrac bit. |
| | Worn-out coupling | Replace worn-out couplings. Change couplings with new shank adapters. Use a bridged coupling sleeve. |
| | Bending due to misalignment | Utilise alignment instruments to monitor hole orientation once the hole has been collared. Replace wear pads on feed. |
| | Heavy rotational torque caused by drilling with a worn bit giving high reflected energy | Regrind the bit when the wear flats are max. 1/3 of the button diameter. |
| | Continued percussion with stuck rod in broken rock | Activate anti-jamming when drilling. |

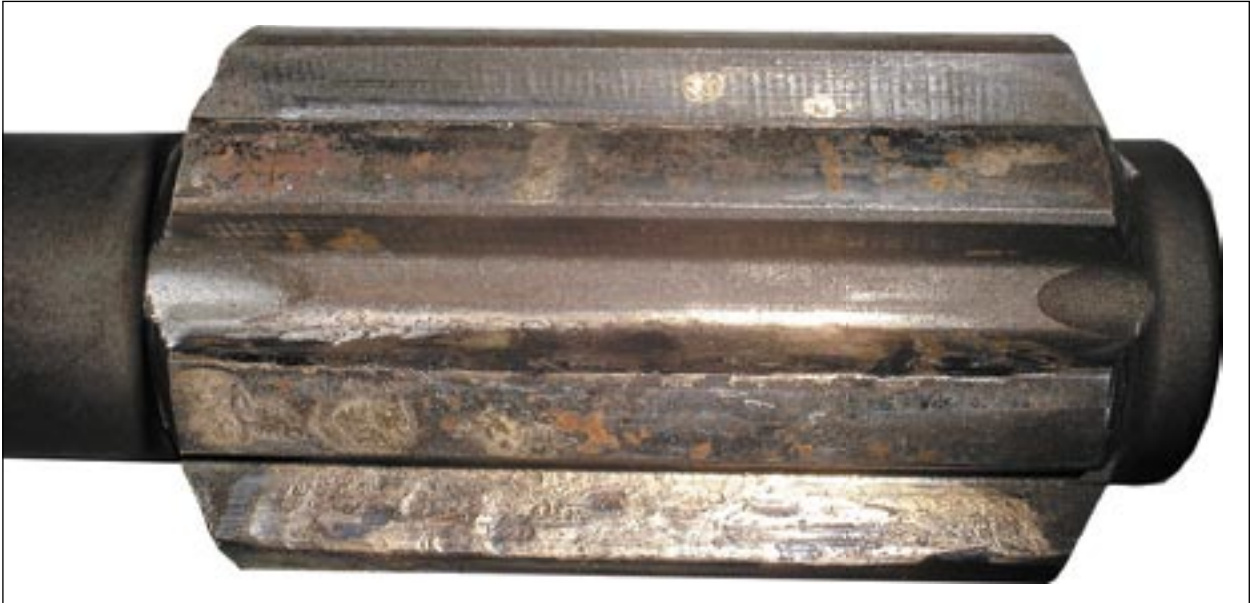
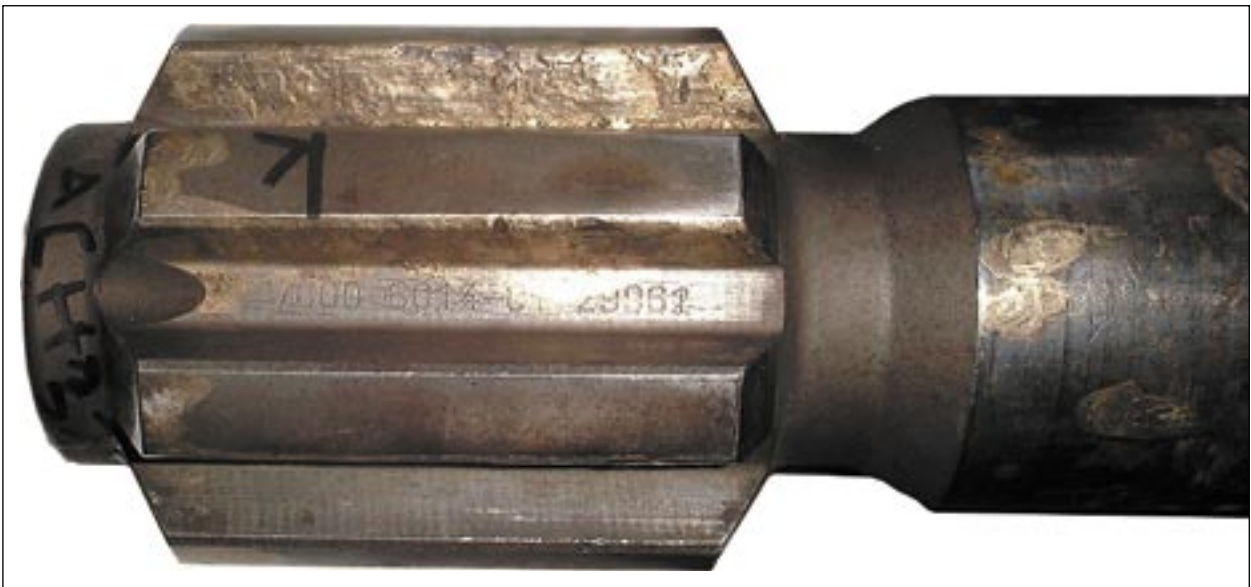
### F:9 PITTING AND GALLING ON SPLINES

Error code C3

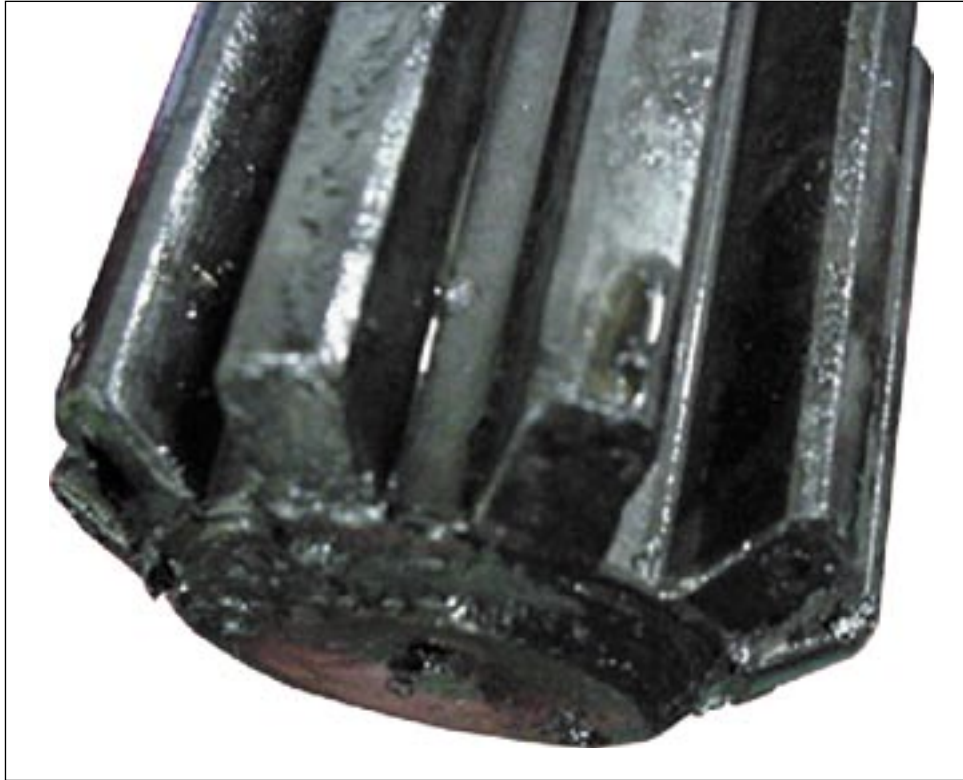
### F:10 EXCESSIVE WEAR ON TOP OF SPLINE SHOULDER

*Error code C3*

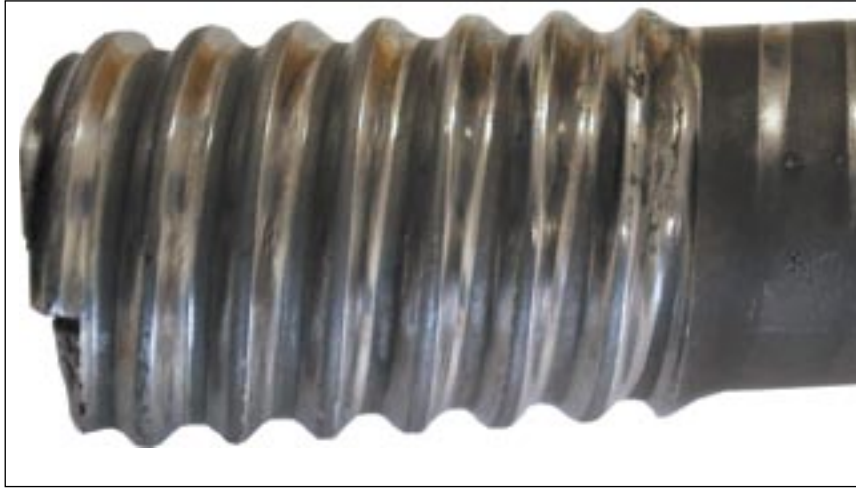
### F:11 CHIPPED THREAD END

*Error code B4*

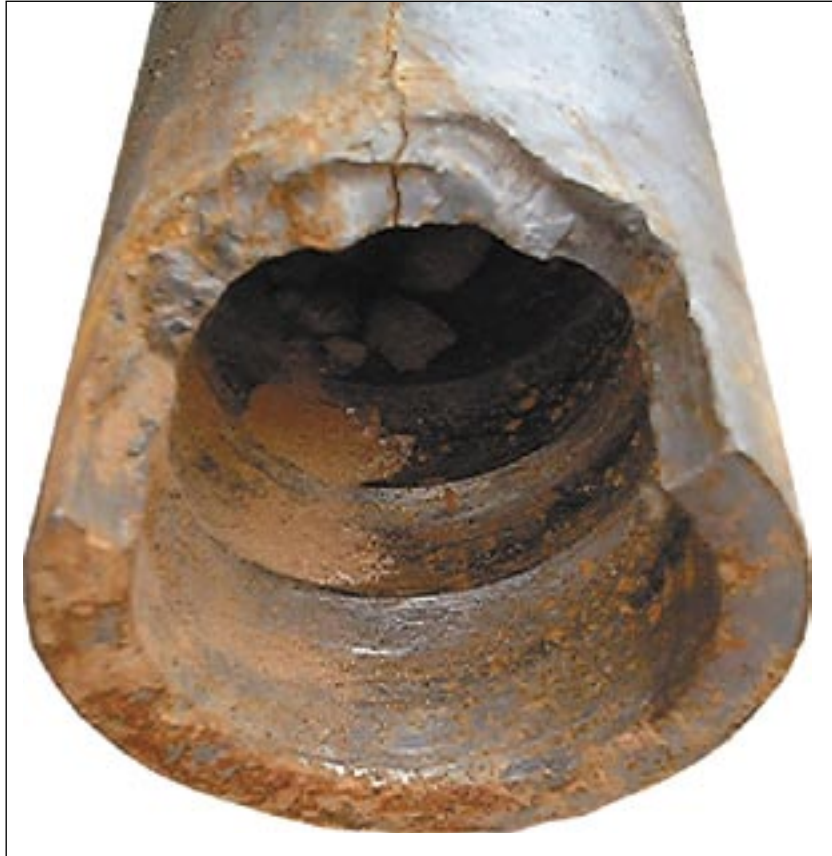
### G:1 IMPACT MARKS, CHIPPED END

*Error code B4*

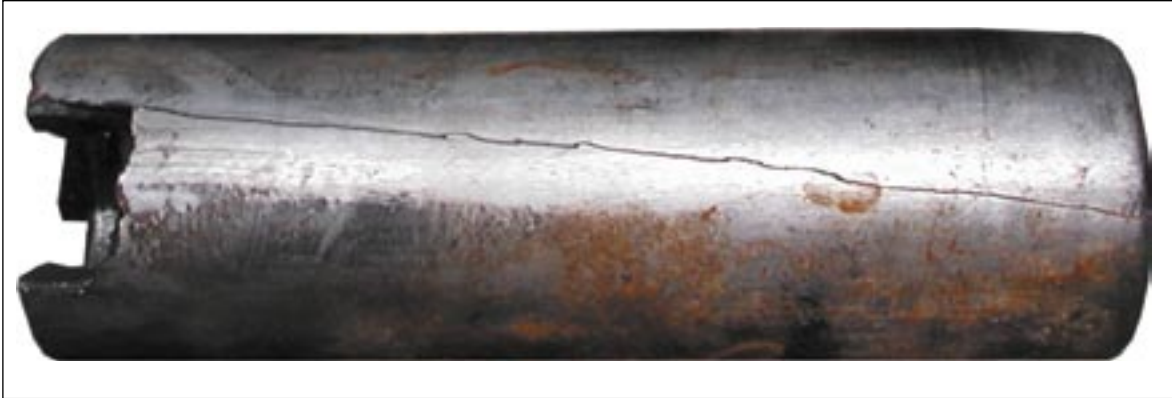
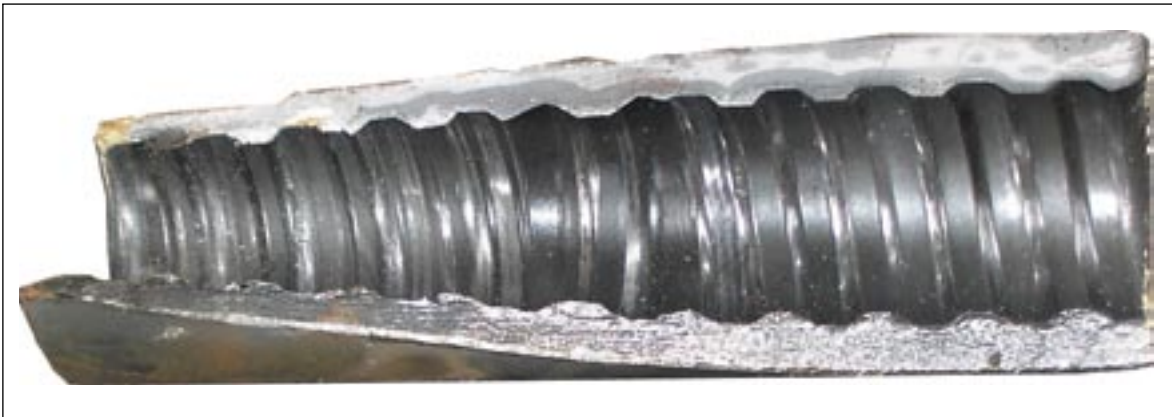
### G:2 LONGITUDINAL CRACK

Error code B2

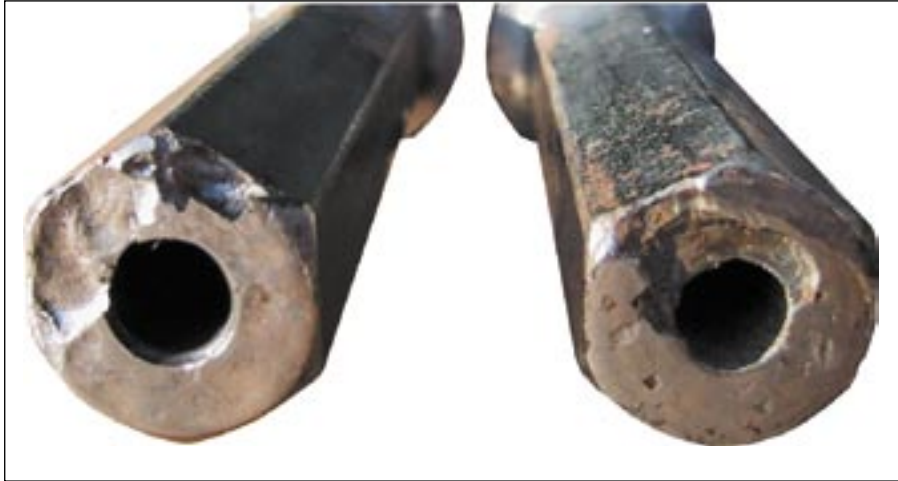
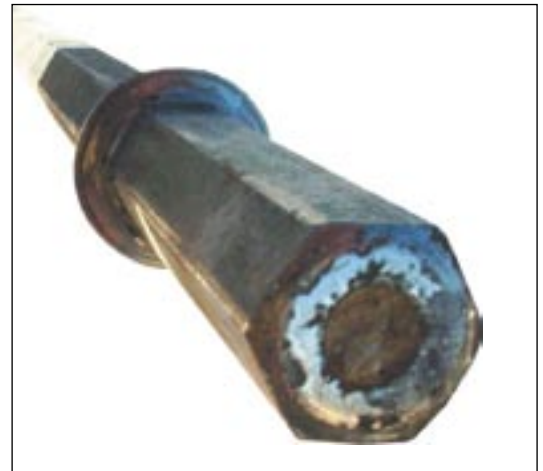
### H:2 STRIKING FACE DEFORMED

Error code C2

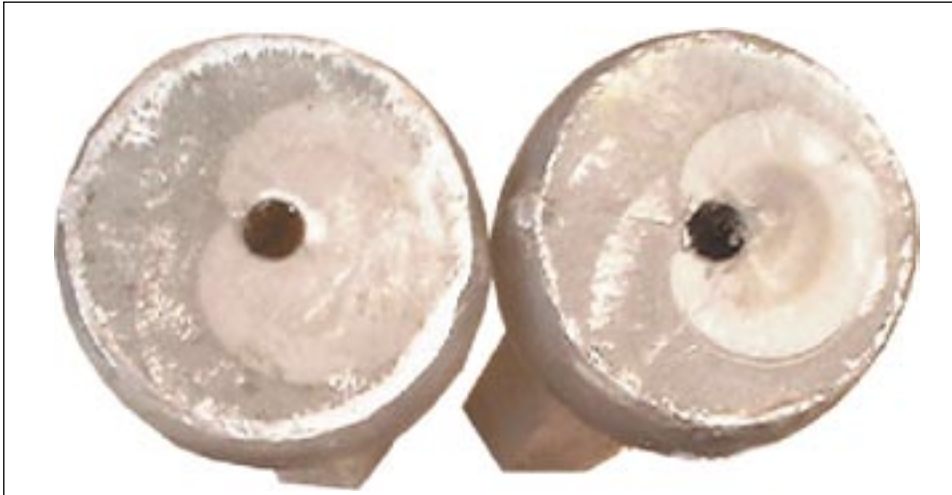
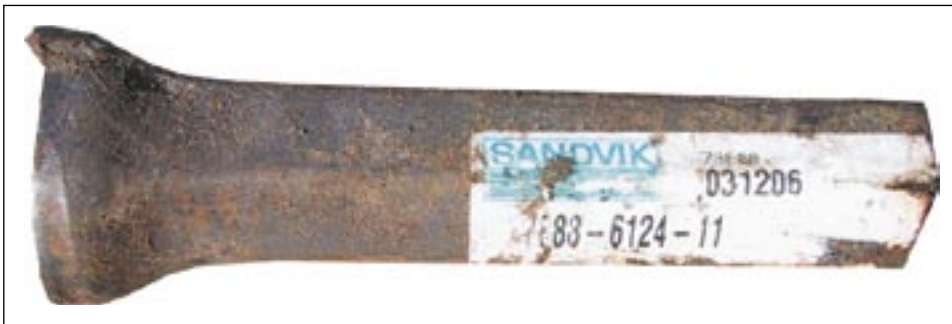
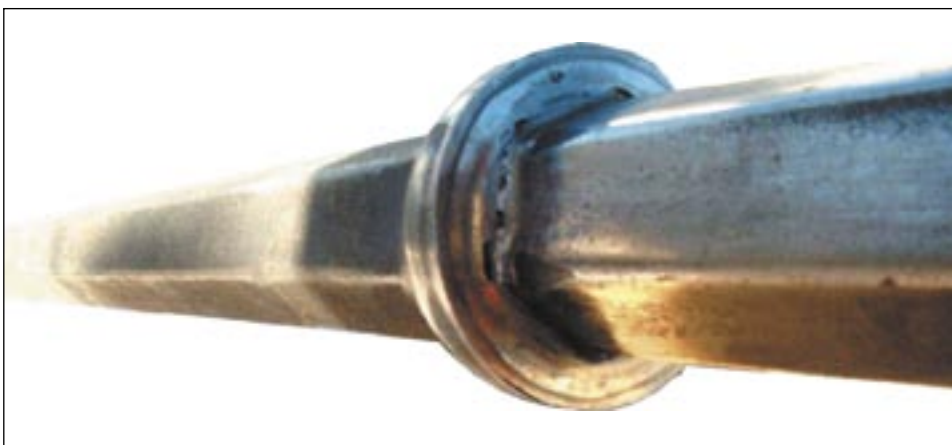
### H:3 WEAR OR BREAKAGE AT BEGINNING OF COLLAR RADIUS

Error code B1

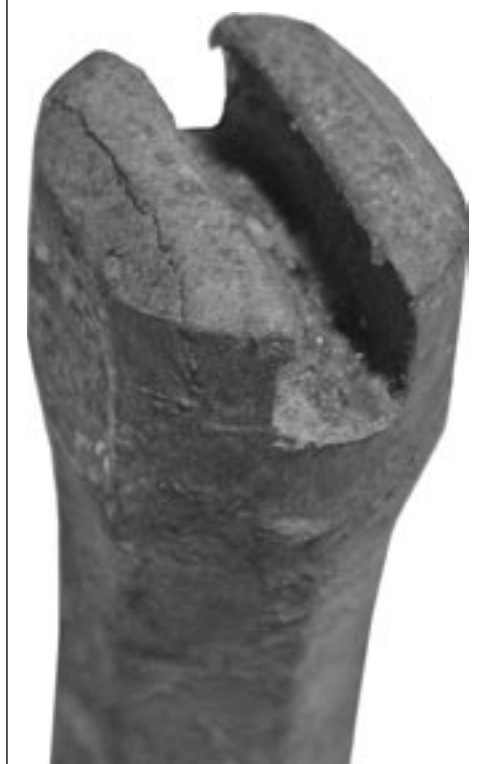
### H:8 FAILURE IN THE JOINT

*Error code L*

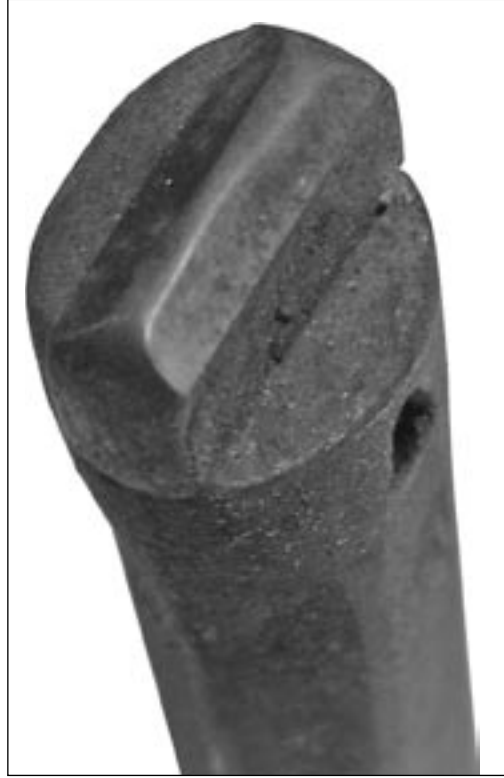
### H:9 FAILURE IN THE WING

*Error code F*

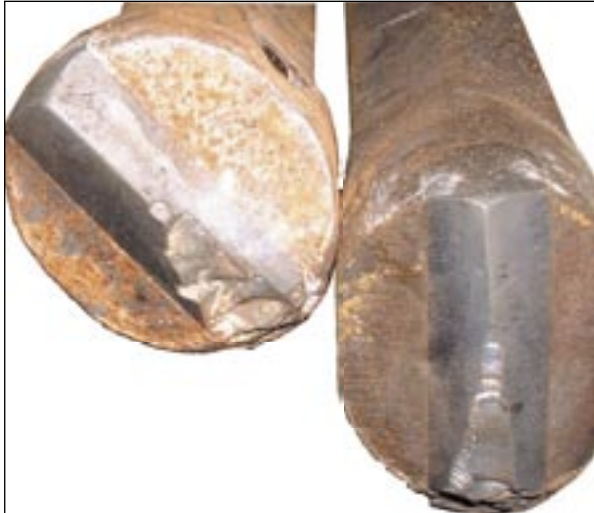
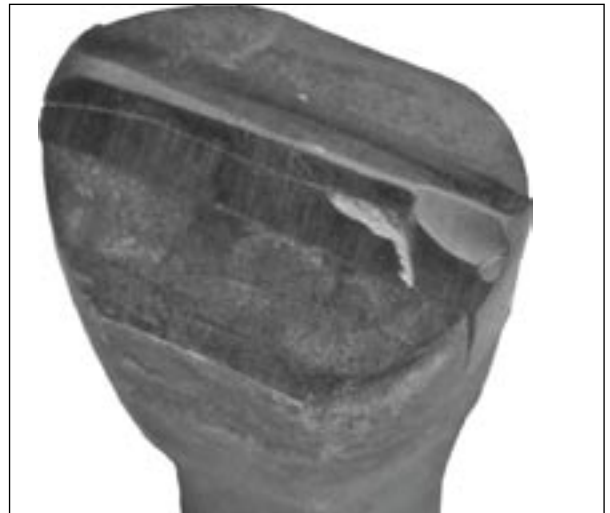
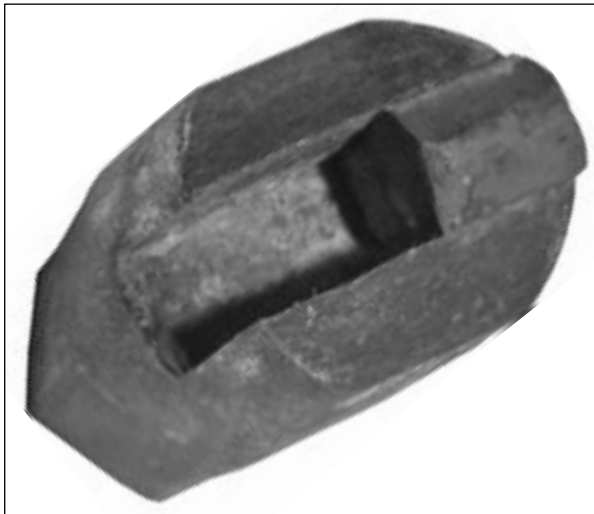
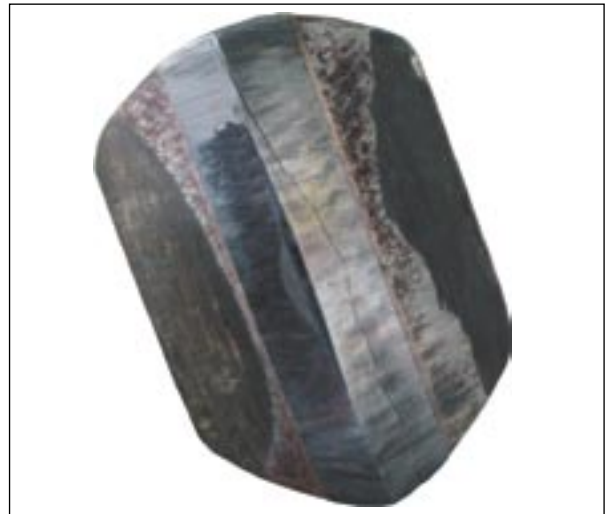
### H:10 FAILURE IN THE CARBIDE

Error code S

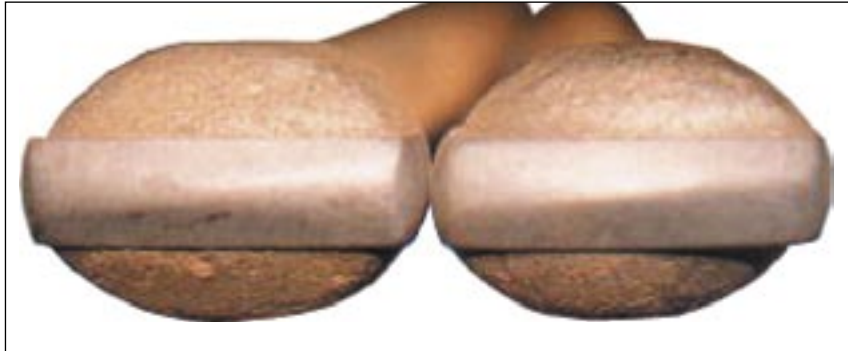
### H:11 PROPELLER WEAR
